Chautauqua Wildfire Mitigation Plan Phase 2 Final Report

SHF Grant #2022-M2-001
Form+Works Project No. 22-040

Chautauqua Wildfire Mitigation Plan

Phase 2

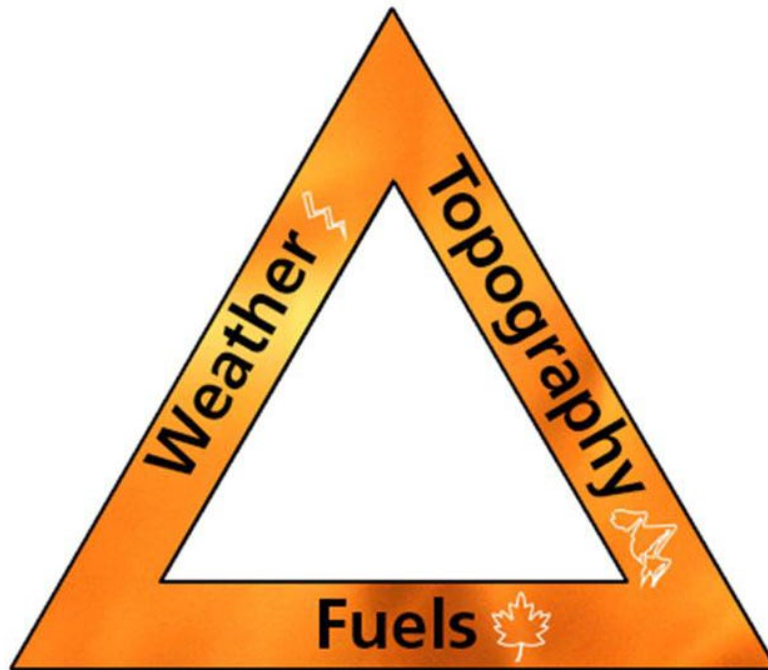
Figure 1: The Fire Triangle

Fuels, weather, and topography are the key factors in wildland fire behavior. As shown in the well-known fire triangle in Figure 1, it is the interaction of these three variables that responders must address when allocating resources to protect life and property.

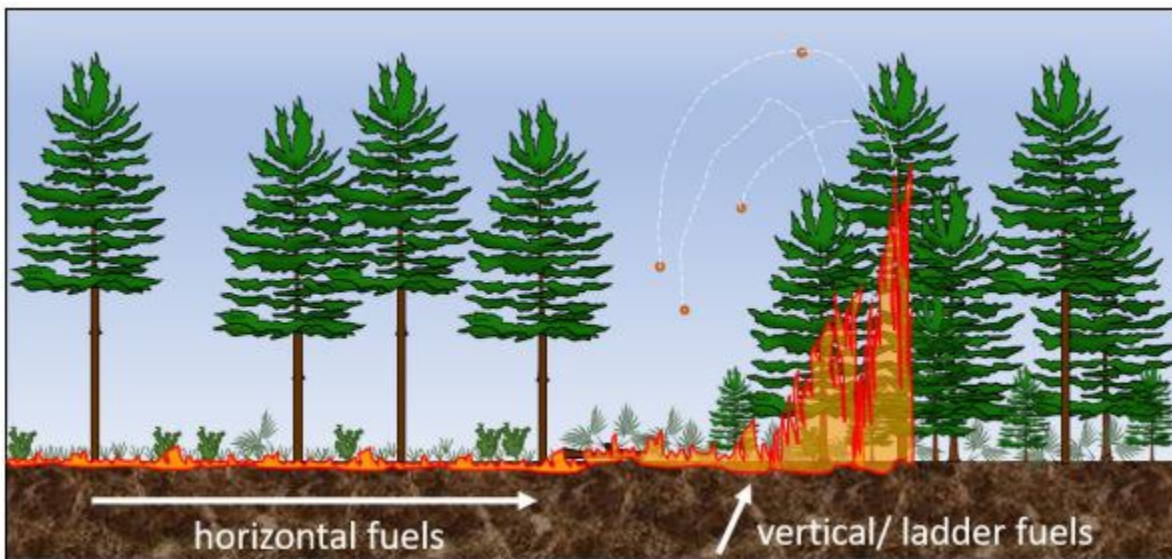
Figure 2: Diagram Horizontal Fuel and Vertical/Ladder Fuels (Campbell, 2020)

The two primary means of significantly reducing the immediate risk to structure in the WUI are fuels mitigation and creating defensible space. Fuel mitigation involves removing or trimming vegetation to reduce the total volume of material that can burn (the fuel load) while reducing the horizontal and vertical continuity of the fuel to lower the likelihood of the fire being able to spread without interruption, as across a grassy meadow (see (Campbell, 2020)Figure 2). Horizontal fuel continuity is vegetation or other fuel that is continuous, or touching, across the horizontal plane, e.g., there is little or no separation from tree to tree, shrub to shrub, or grasses in a large meadow. Similarly, vertical fuel / ladder fuels continuity is a lack of separation vertically, e.g., grass to shrubs to tree branches to the crowns of the trees would be a typical example.

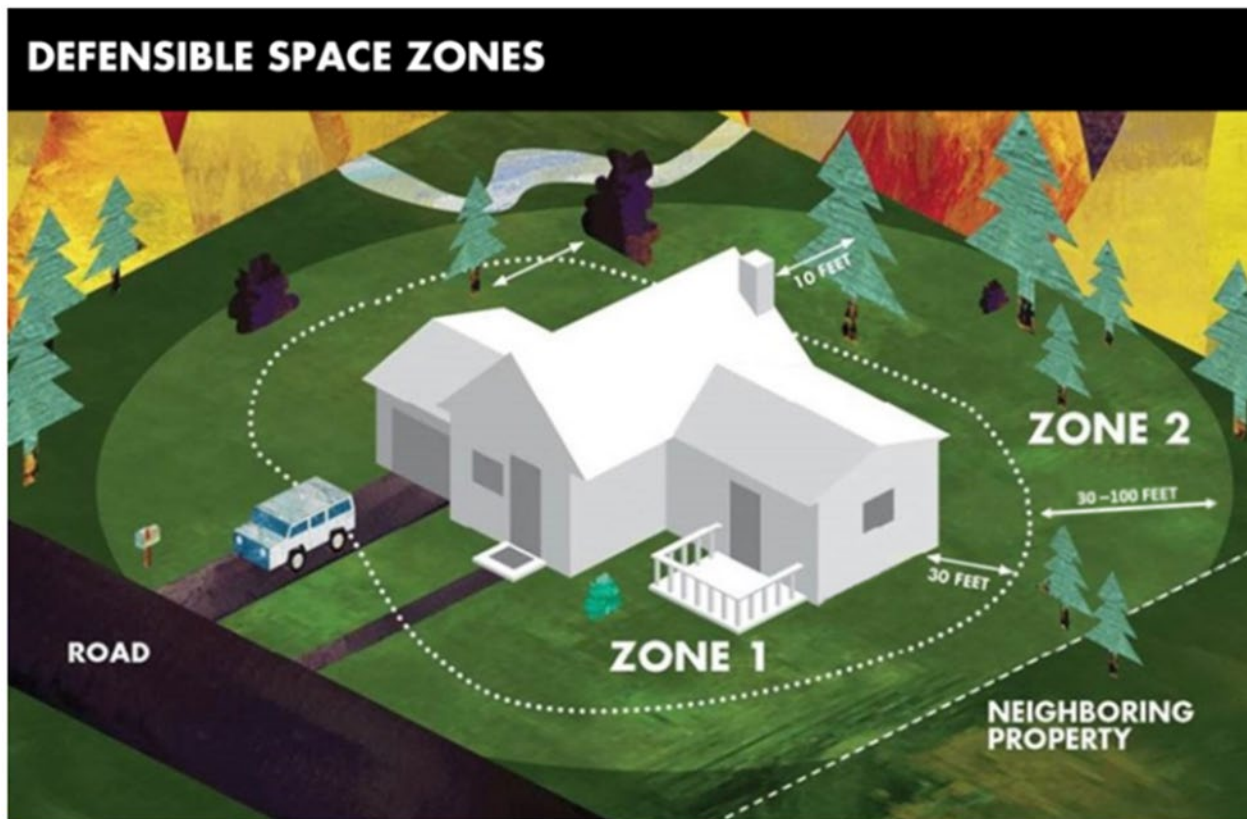
Figure 3: Idealized defensible space that is recommended around a single residential structure. This approach is often not feasible for cultural resource sites due to proximity of other structures, heritage trees, or other features that are significant to the cultural landscape.

role of building materials on the risk of damage or loss due to fire. Figure 3 and Figure 4 show examples of what are promoted as best practices for establishing defensible space around newly planned residential structures in fire-prone areas prior to construction. These recommendations are good guidance for many single structures in the WUI but not so appropriate for sites with closely spaced buildings and with designated landscape and/or site features that have a historic designation or may be eligible for one. For this reason, consultation between cultural resource specialists, wildfire personnel, and building stewards is likely to result in a compromise when evaluating and determining a fuels mitigation plan and creating defensible space around a historic building or site, rather than the idealized mitigation approaches conveyed in Figure 3 and Figure 4.

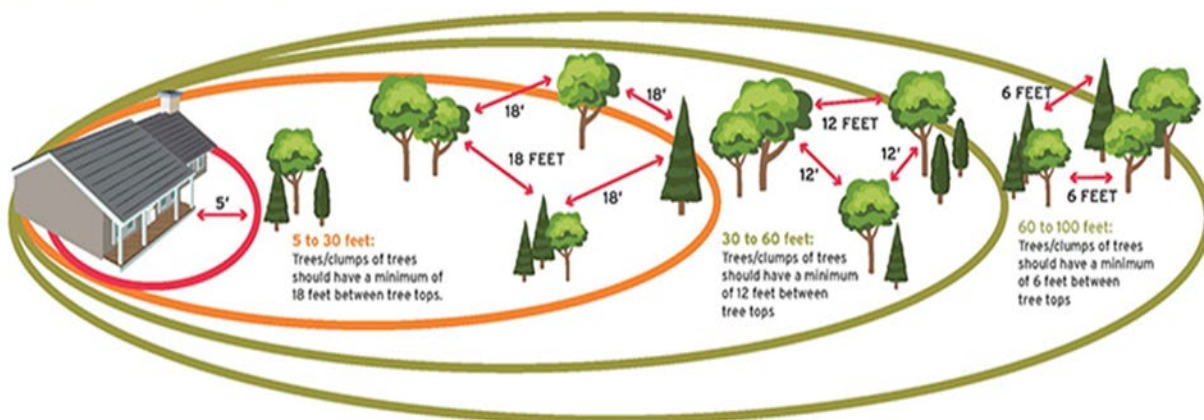
Figure 4: Defensible space as recommended by removing or trimming vegetation to eliminate horizontal and vertical fuel continuity to reduce the risk of the fire spreading and making fire operations more challenging and less safe. As is the case for Figure 3, this approach is often not feasible for cultural resource sites due to proximity of other structures, heritage tress, or other features that are significant to the cultural landscape. (Wildfire Mitigation and Preparedness, 2023)

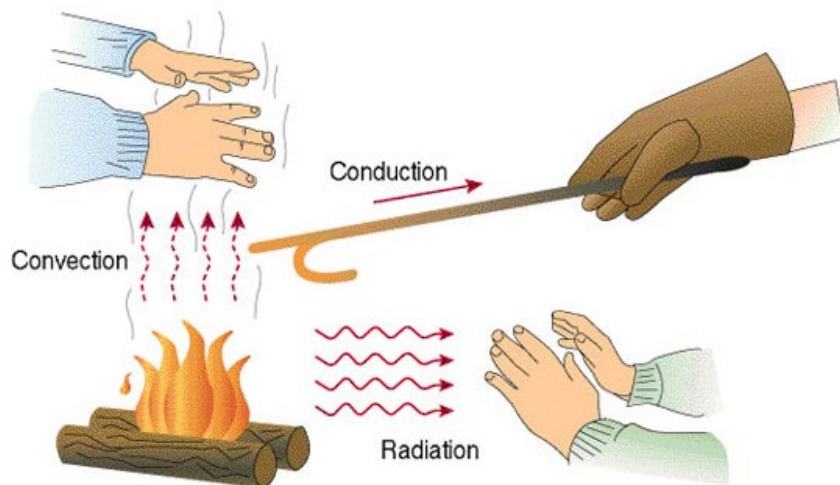
Figure 5: Diagram of Convection, Conduction, and Radiation Heat (Shirley, 2015)

Heat transfer occurs through convection, radiation, or conduction. Convection is the movement of hot air due to heating of the air molecules. Convection is the primary means of fire spread by pre-heating fuels in advance of the fire, including the upper crowns of trees. Radiation is the movement of heat energy as waves pass through the air. The heat is transferred when the wave reaches a physical object that conducts heat. Radiant heat from a wildfire can ignite combustible materials inside a structure from several hundred feet away in extreme events. Conduction occurs when heat is transferred from molecule to molecule through direct contact, such as when one touches a hot skillet, see Figure 5.

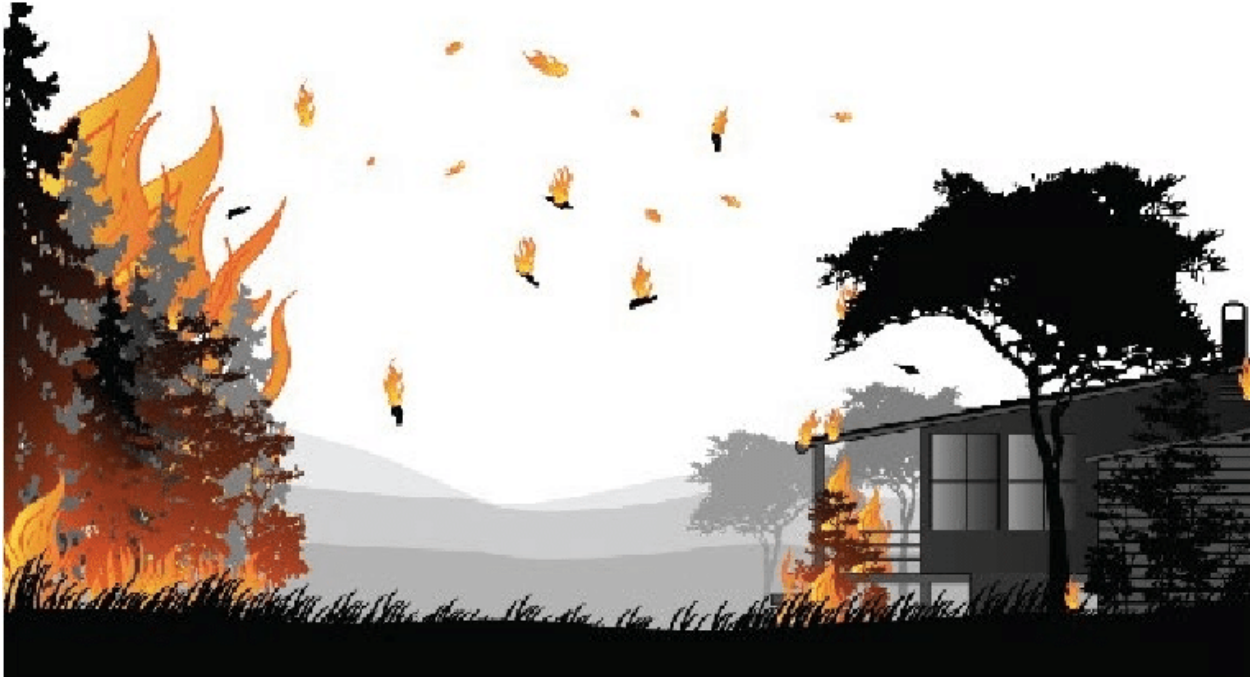
Figure 6: Illustration of Firebrand / Embers Traveling from Fire to Structure (Walls, 2023)

Firebrands, or embers, are airborne burning materials that can cause ignition when they come in contact with unburned fuel. Embers can be from vegetation (pinecones, sticks, leaves, etc.), structures (roofing, siding, even roof sections, etc.), or other burning materials. Wind can carry the embers long distances, farther than convection or radiation can transfer heat for combustion, and upon landing can ignite vegetation or get into openings (e.g., uncovered vents) in structures and start fires on the interior before the flames ever reach the structure, see Figure 6. While embers have always been a concern during wildfires, the wind speeds and gusts recorded in relatively recent fires can travel, or spot, well over a mile in extreme wind events where gusts exceed 60 to 80 mph. Most structures lost to wildfire are the result of embers causing ignition of the structure itself, or traveling from ignition of the landscape or elements nearby, thus reinforcing the need for fuels reduction and mitigation.

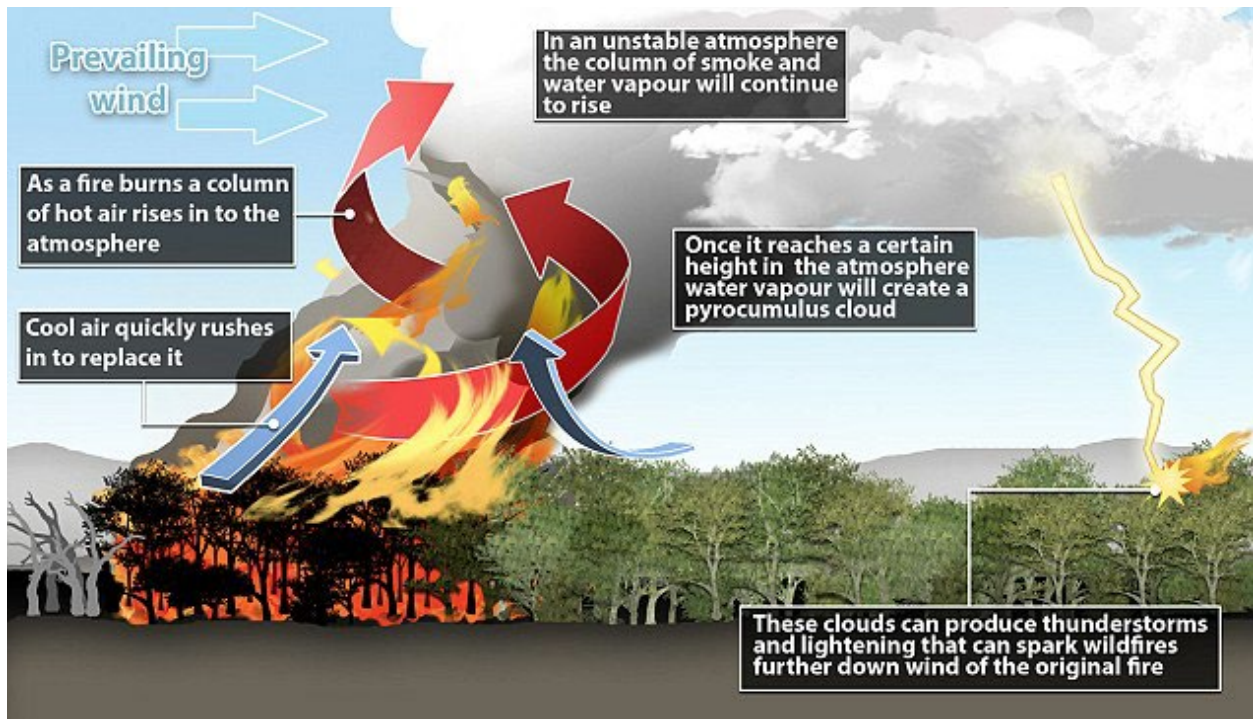
Figure 7: Diagram of a convective column (Pedrógão Grande Fire Timeline, 2018)

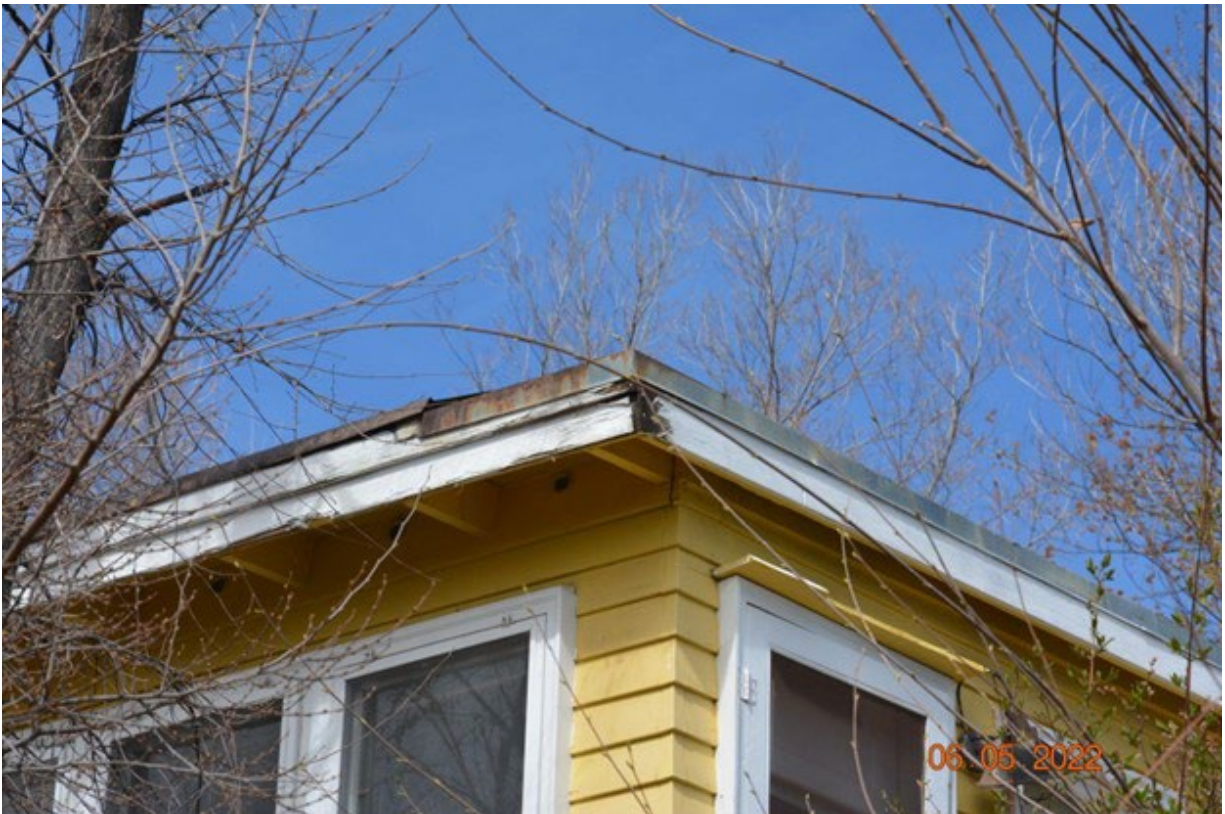
Figure 8: Deteriorated fascia board that provides an entry for wind-blown embers can result in an ignition on the interior of the structure.

Ignition occurs when a combustible material reaches a temperature sufficient to support combustion of that material. A general rule is that the majority of fuels will ignite during a wildfire at a temperature of approximately 500 degrees Fahrenheit. Embers (firebrands) that travel through the air due to wind or air currents (such as a convective column, see Figure 7, often seen on large wildfires) are the most common source of structure ignition through spotting. If the embers are large enough to retain heat or are burning when they land on a combustible material, an ignition can occur. Addressing the probability of ignition to or in a structure is critical to reducing the potential impact of embers, particularly during wind-driven fires. Erratic winds can put embers in tight openings that, through conduction, will result in an ignition. Continued maintenance of structures is critical to prevent embers from getting into openings. Ensuring that paint is maintained on exterior woodwork and conducting regular visual inspections to determine entry points for embers should be part of routine maintenance, see Figure 8.

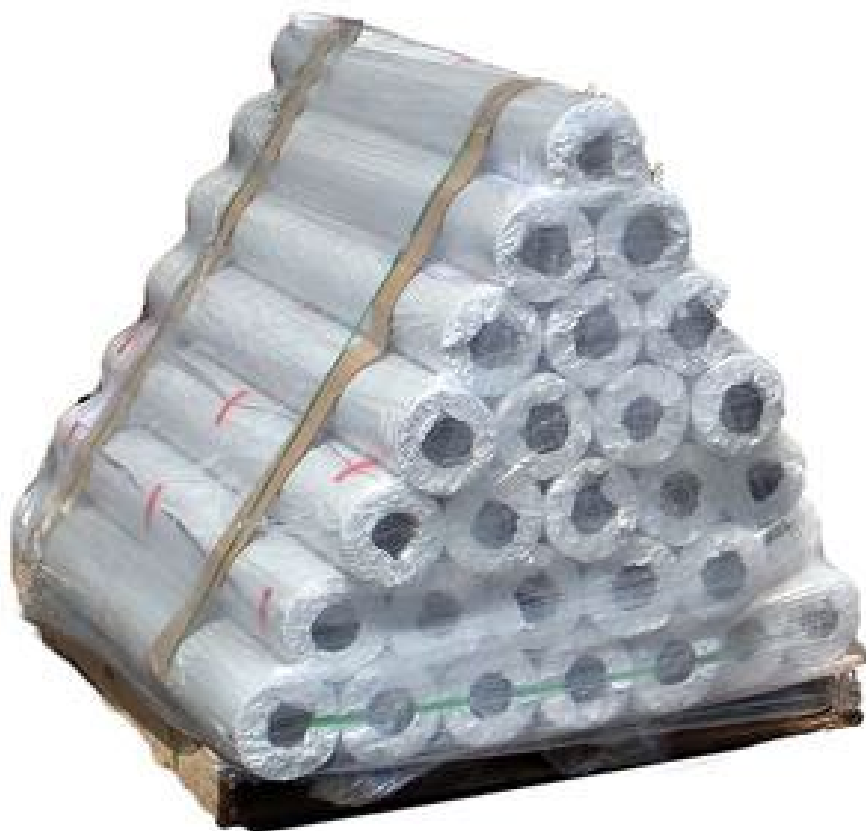
Figure 9: Image of stack of Firezat rolls. Could be stockpiled on-site for use. Image credit: firezat.com, accessed March 21, 2023

This Aluminized Structure Wrap (ASW) product was adapted following the 1988 Yellowstone National Park Fires when the Park’s historic structures were under threat, but crews were forced to leave. As a last-ditch effort, the firefighters cut up their personal fire shelters, stapled them to the historic structures and the buildings were spared (see APPENDIX D: ADDITIONAL

INFORMATION_for brief history of personal fire shelter development). From this incident, the technology developed and studied for personal fire shelters was adapted to create a building wrap for protection during wildfire threat.

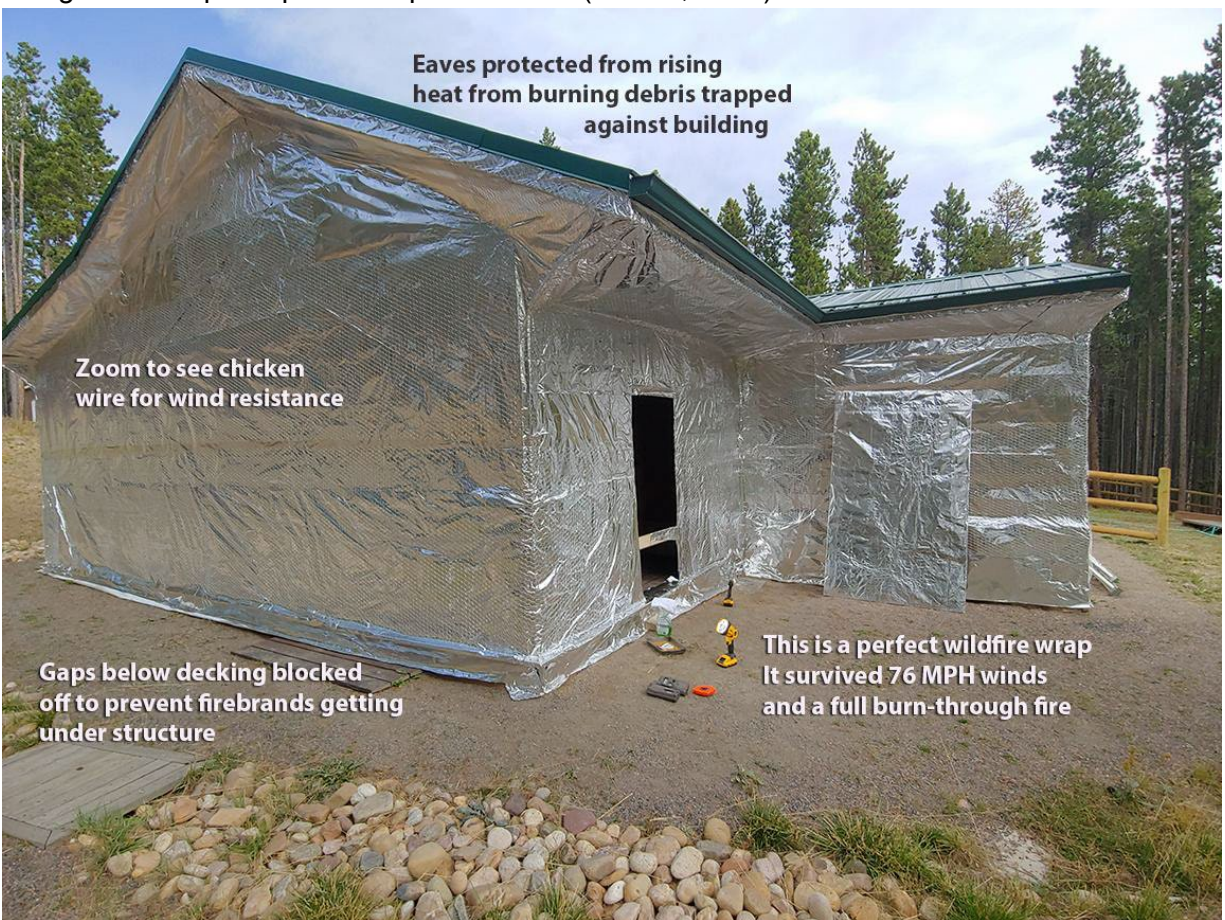
Figure 10: Firezat installation with chicken wire and staples. Building has an existing metal roof eliminating the need to wrap the roof. Image credit: firezat.com, accessed March 21, 2023

Conclusion: This is a temporary protective measure that has a relatively high level of reversibility with regards to the SOI standard, i.e., holes from chicken wire with staple method of install can be filled, although installing the wrap can use thousands of staples that can damage weathered wood that is friable. It has been utilized by the Forest Service, National Park Service, and the Bureau of Land Management, to name a few, and is proven to protect critical structures from embers, radiant heat and direct flames. There are a significant amount of case studies and testing to back-up this product's performance (Firezat, 2023).

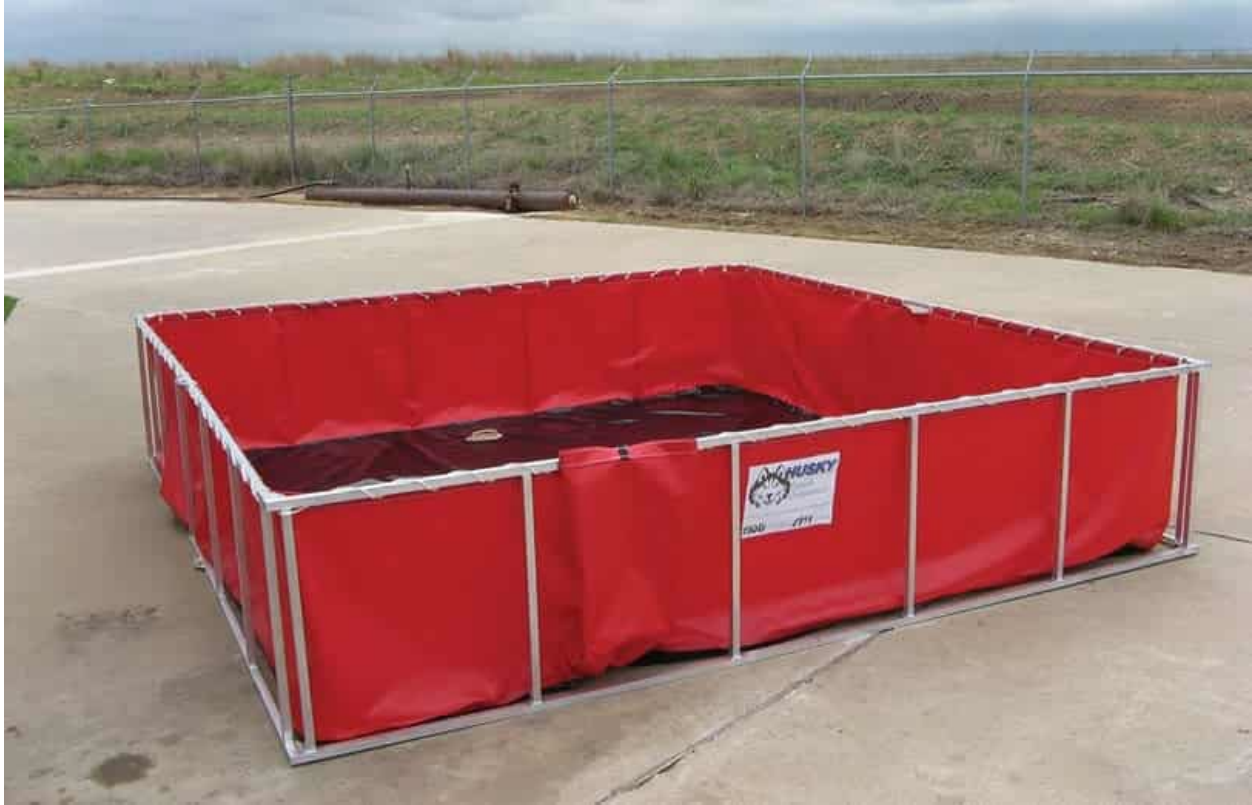
Figure 11: Image of a Husky Portable Water Tank (Husky Portable Folding Frame Water Tanks, 2023)

In addition to the sprinklers and portable fire pump, collapsible water storage tanks may be an essential component for a successful sprinkler operation. Tanks can be stored when not in use and expanded and filled with water prior to arrival of the fire. The water supply can be domestic supply from buildings, fire hydrants (although hydrants not intended for use by the public) and can be refilled by water tenders during fire operations. They are often used during fire operations to refill fire apparatus that are too far from hydrants or other water sources to maintain continuity in the firefighting operation due to long turn-around times. Tanks can hold a few hundred gallons up to several thousand gallons of water. There is a liability of having an open water tank on site due to the risk of drowning if someone (a child) should inadvertently have access to the tank. There are various manufacturers and types of collapsible water storage tanks, a couple of manufacturers include: Feld Fire (Portable Water Tank - Steel Frame, 2023); Husky Portable Containment (Husky Portable Folding Frame Water Tanks, 2023) and Fol-Da-Tank (Fol-Da-Tank Collapsible Fire Department Frameless Water Tank, 2023). Capacity (sizes) vary per manufacturer and product but range from 250 to 10,000 gallons. Similarly costs vary from \$700 to \$8,000. Additional consideration would be needed to determine the correct sizing and product to purchase.

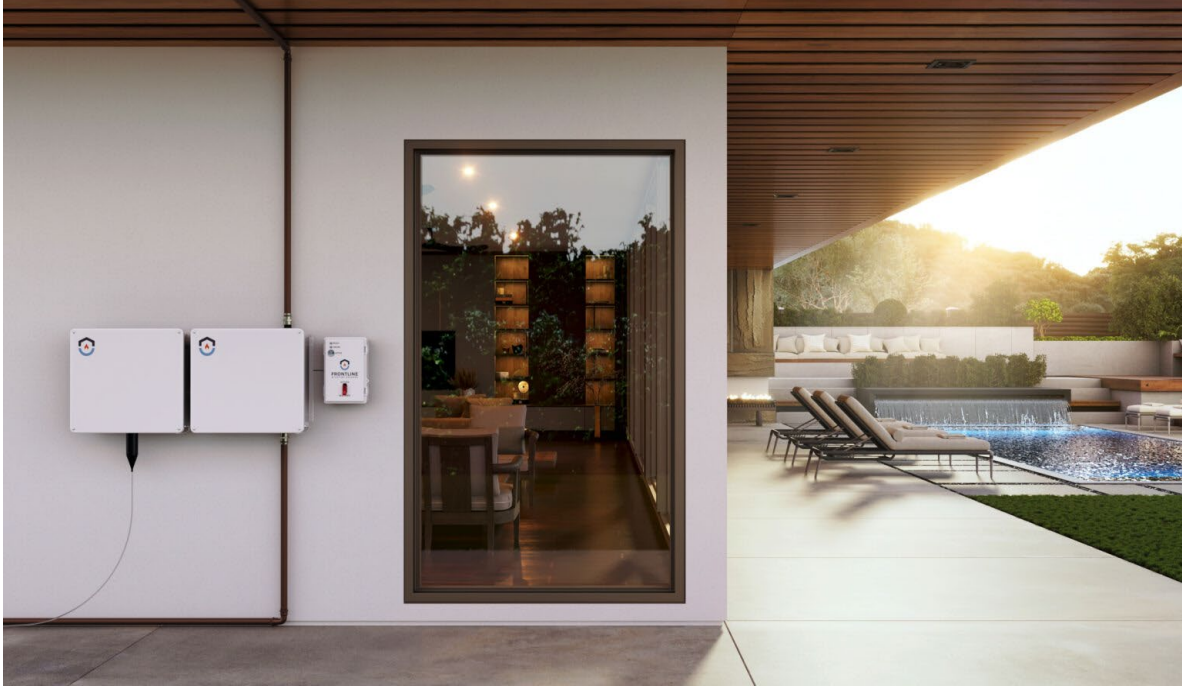
Figure 14: Defense System 2 Website Photo Control System and Surface-Run Piping, Accessed May 23, 2023

The system offers manual and remote activation options. A typical system will use the building's primary water source first; if there is a drop in pressure, the system will automatically switch to a secondary water source such as a pool, tank or well. The system is designed to mitigate the risk of ember ignition during a wildfire.

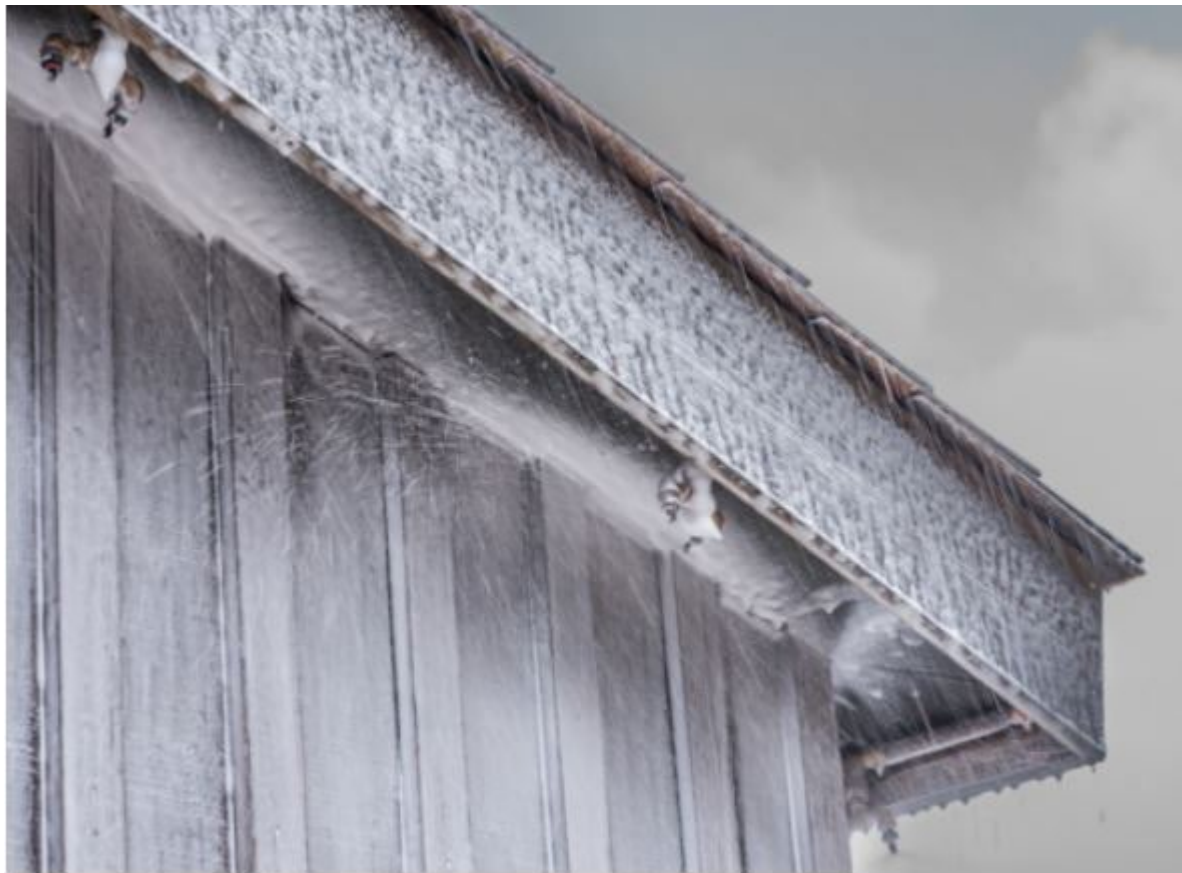
Figure 15: Defense System 2 Website Photo Soffit Sprinklers and Foam, Accessed May 23, 2023

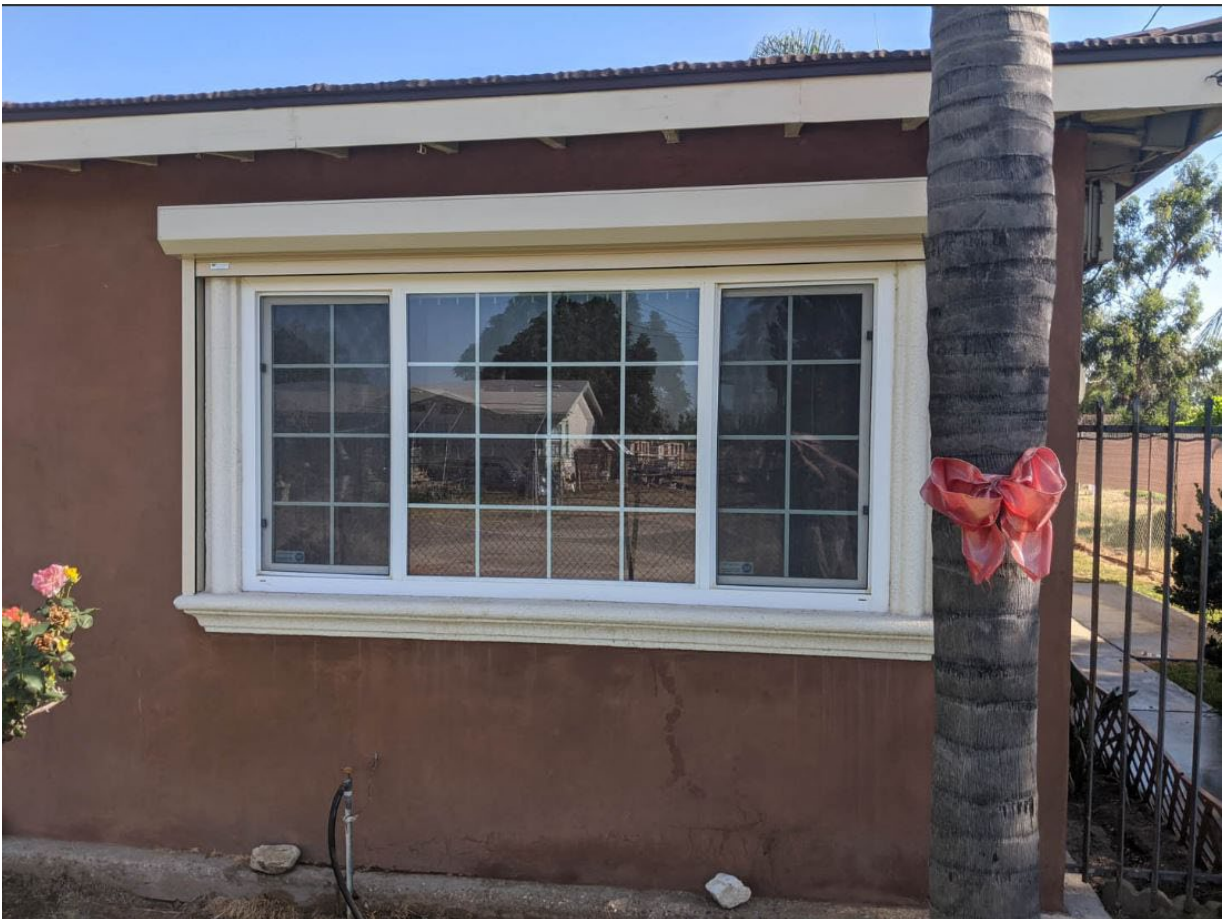
Figure 16: Enviroblind shutter in open position. Image credit: enviroblind.com, accessed March 21, 2023

These exterior rolling shutters are installed over a building's windows and doors, but do not have an official fire-rating. The shutters provide a physical barrier to reduce radiant and convective heat from entering the building and igniting objects. They also offer a barrier to flying debris or falling objects that might break through windows and doors. The shutters can be operated manually by a push button or on an automated system with an electric motor and hard-wired switch.

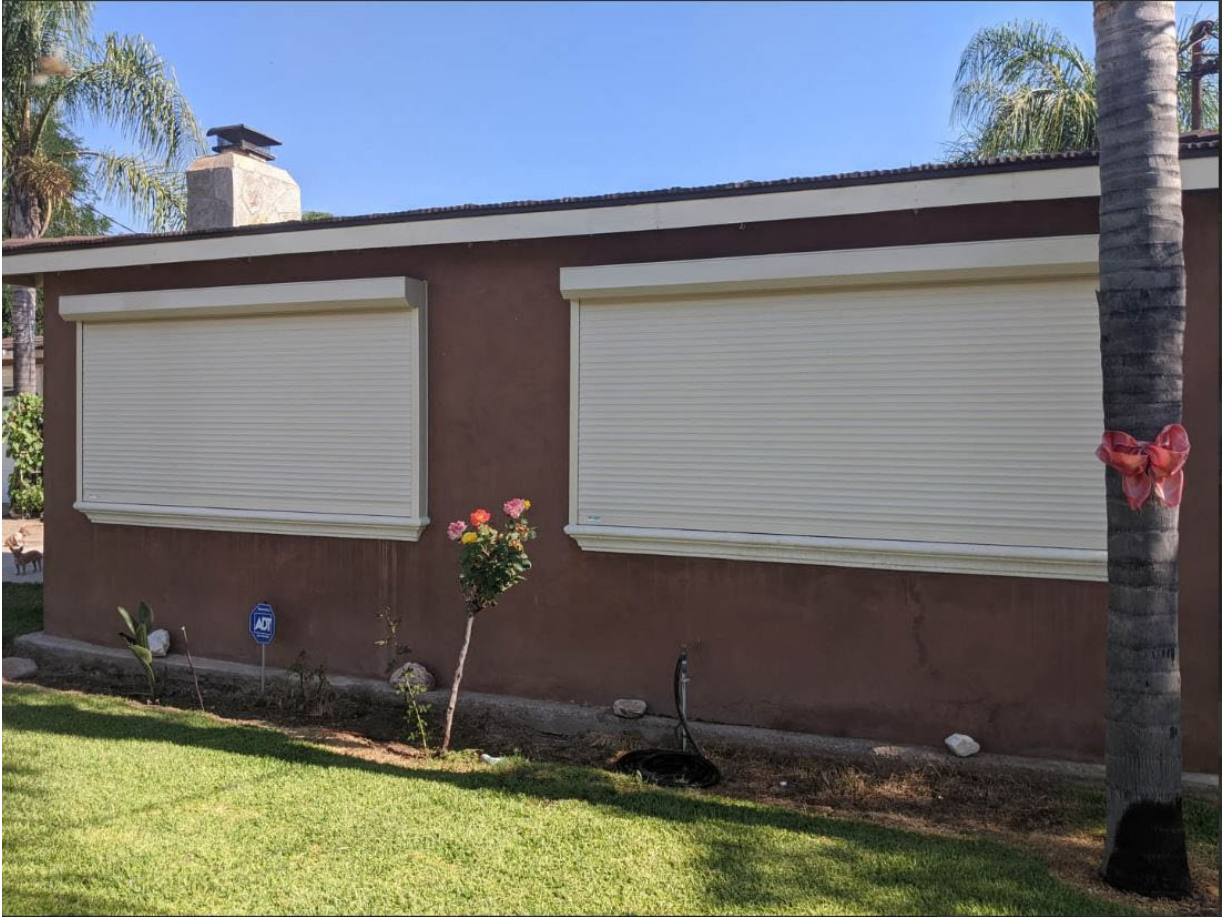
Figure 17: Enviroblind shutter in closed position. Image credit: enviroblind.com, accessed March 21, 2023

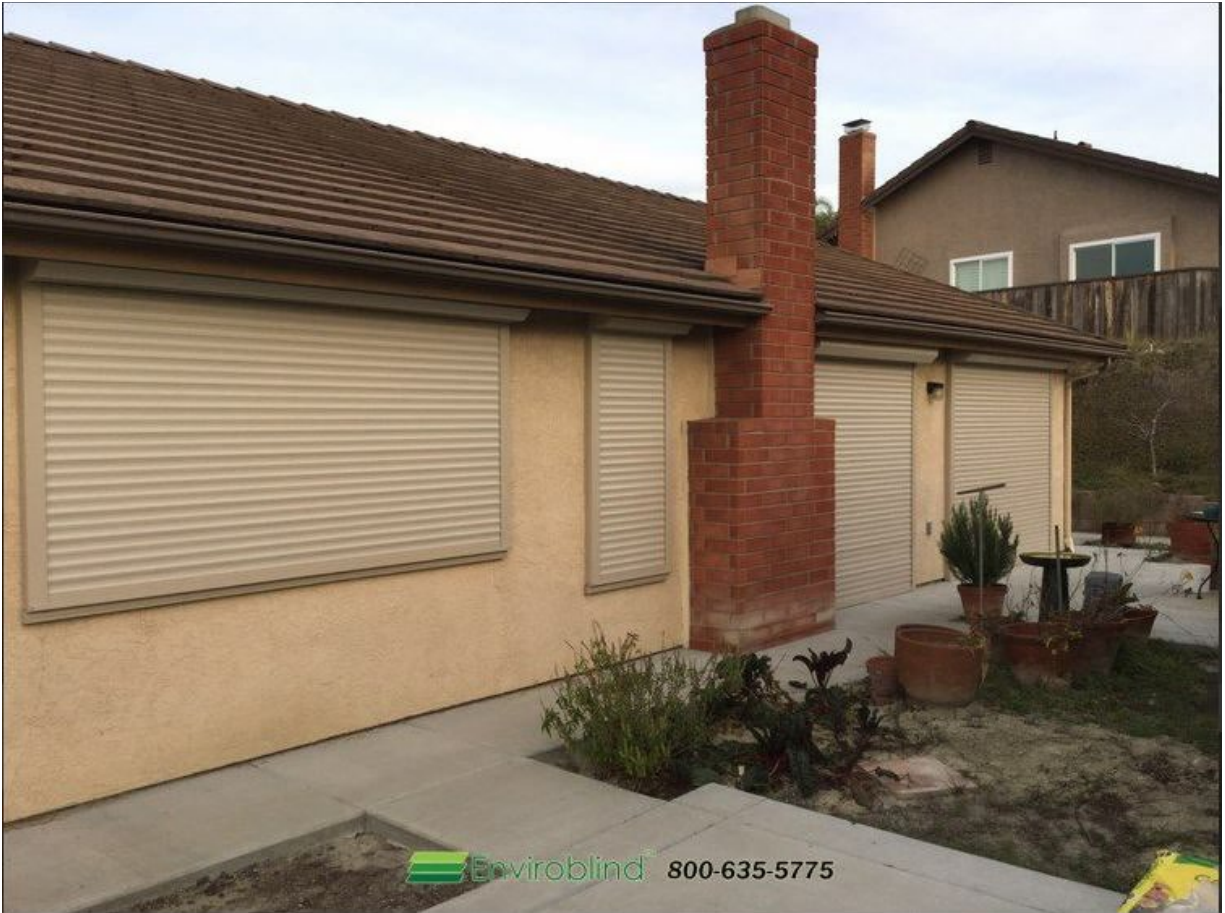
Figure 18: Enviroblind shutters on various sized windows and doors in closed position. Image credit: enviroblind.com, accessed March 21, 2023

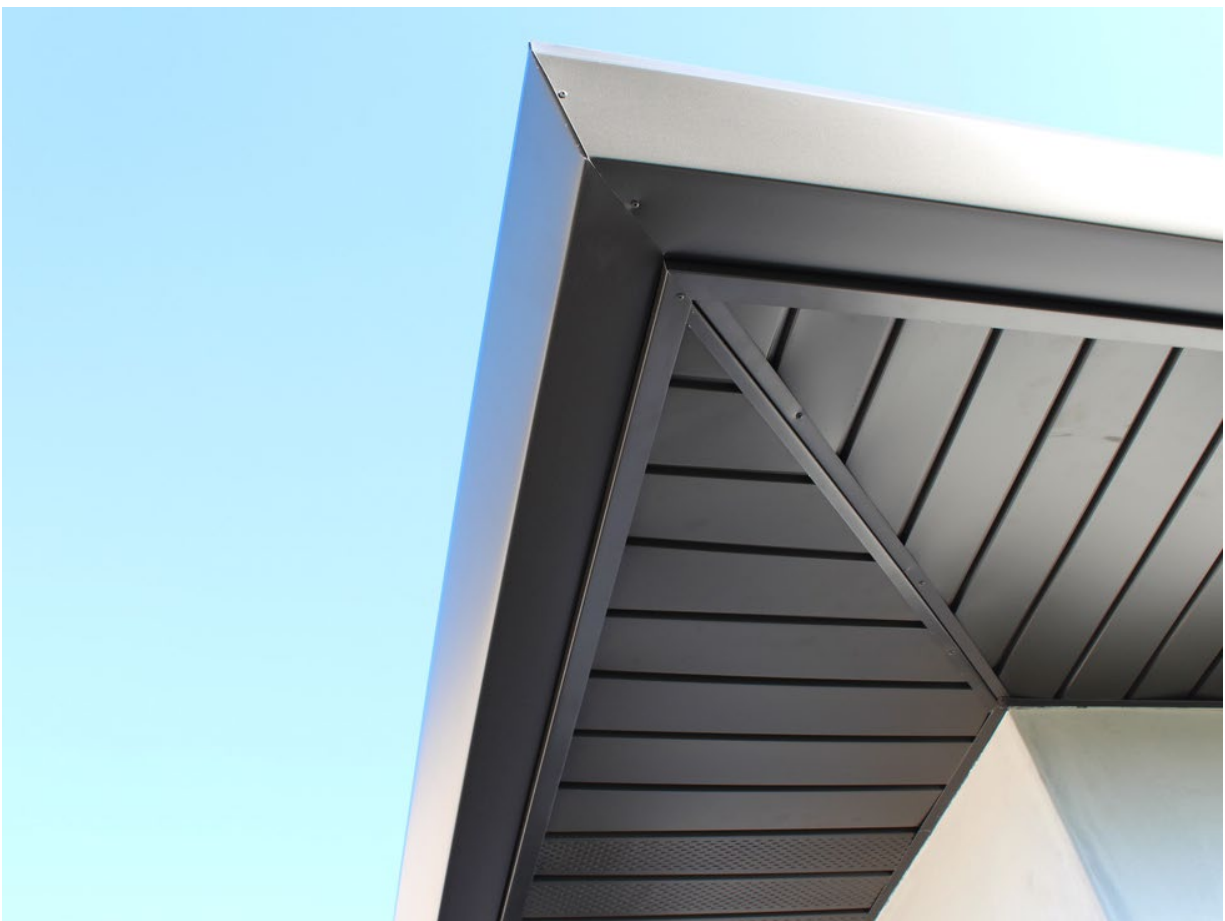
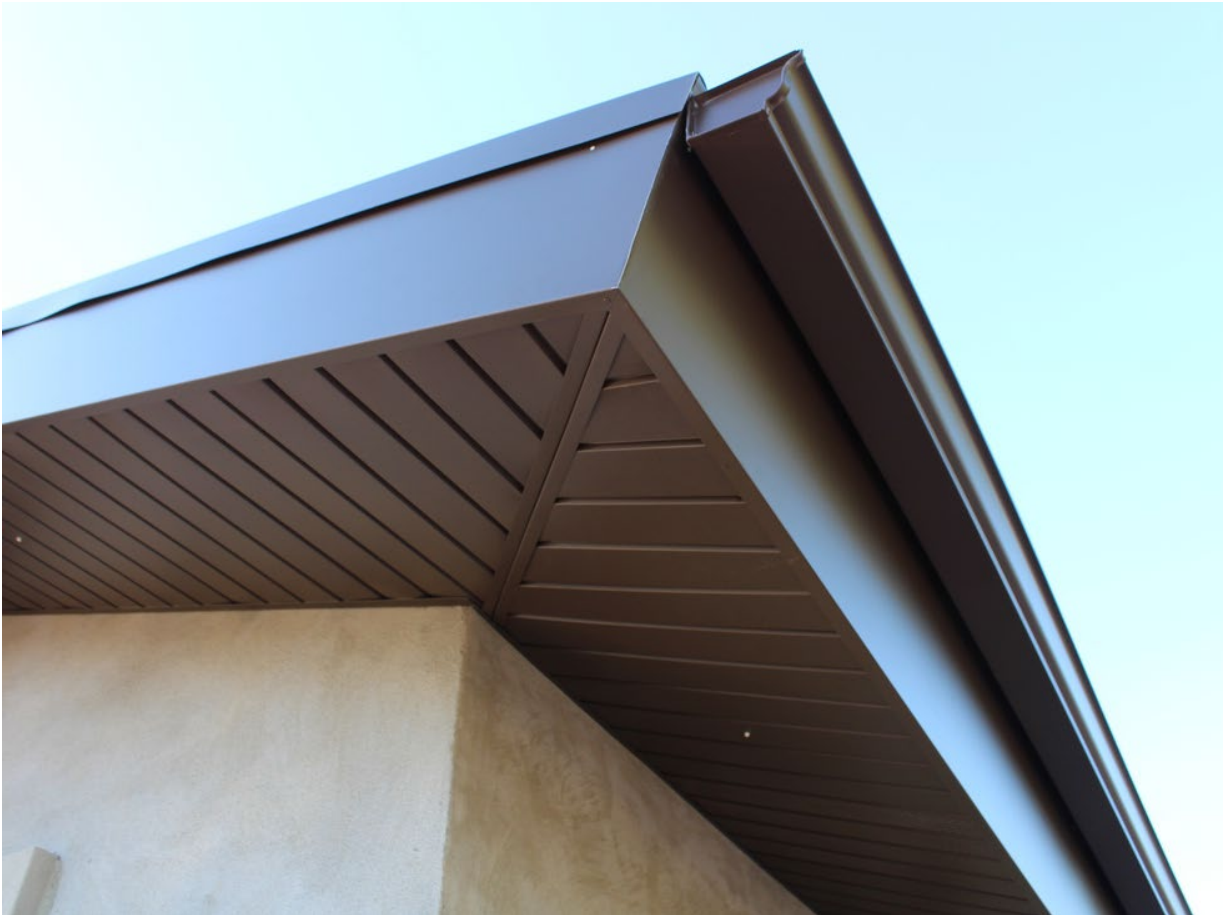
Figure 19: A Plus Gutter Systems of Los Angeles and Orange County, Photo of soffit and fascia retrofitting with sheet metal, Accessed May 17, 2023

Figure 20: A Plus Gutter Systems of Los Angeles and Orange County, Photo of soffit and fascia retrofitting with sheet metal, Accessed May 17, 2023

One potential solution to respond to the ignition risk of wood soffits and trims is to enclose them with sheet metal. There are companies that do this sort of treatment, made more common in California due to their wildfires. A Plus Gutter Systems of Los Angeles and Orange County (A Plus Gutter Systems, Undated) has several photos of work they have completed, see Figure 15 and Figure 16.

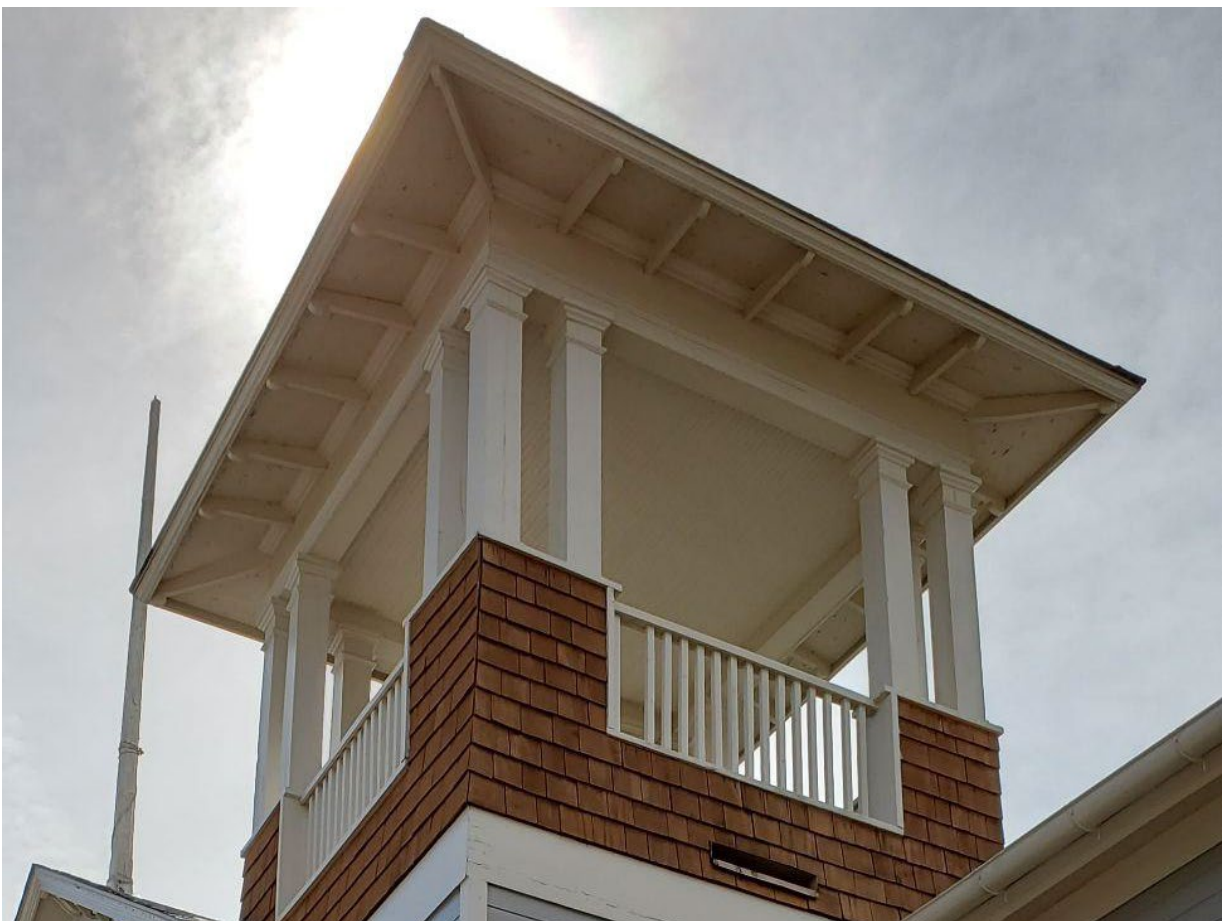
Figure 21: Chautauqua Dining Hall Tower, Exposed wood soffits with carved rafter tails (Lord, 2022)

Conclusion: This treatment is highly visible and alters the appearance of the building, changing the feeling, materials, design and workmanship associated with historic integrity. Technically this would be nearly reversible from the perspective that the enclosures could be removed, mounting penetrations repaired, and the historic materials remain below. As a standalone treatment, enclosing soffits and fascias would be nearly useless, but as part of a cohesive non-combustible exterior envelope (which would include siding, trim, vents, decking, roofing, etc.) it might warrant further consideration, for the entire structure or for specific elevations at high risk for wildfire exposure. However, this concession would need strong justification and consultation with historic preservation authorities for approval. This application would be a great impact on character defining features for a building like the Chautauqua Dining Hall, which has decorative carved open rafter tails, see Figure 21.

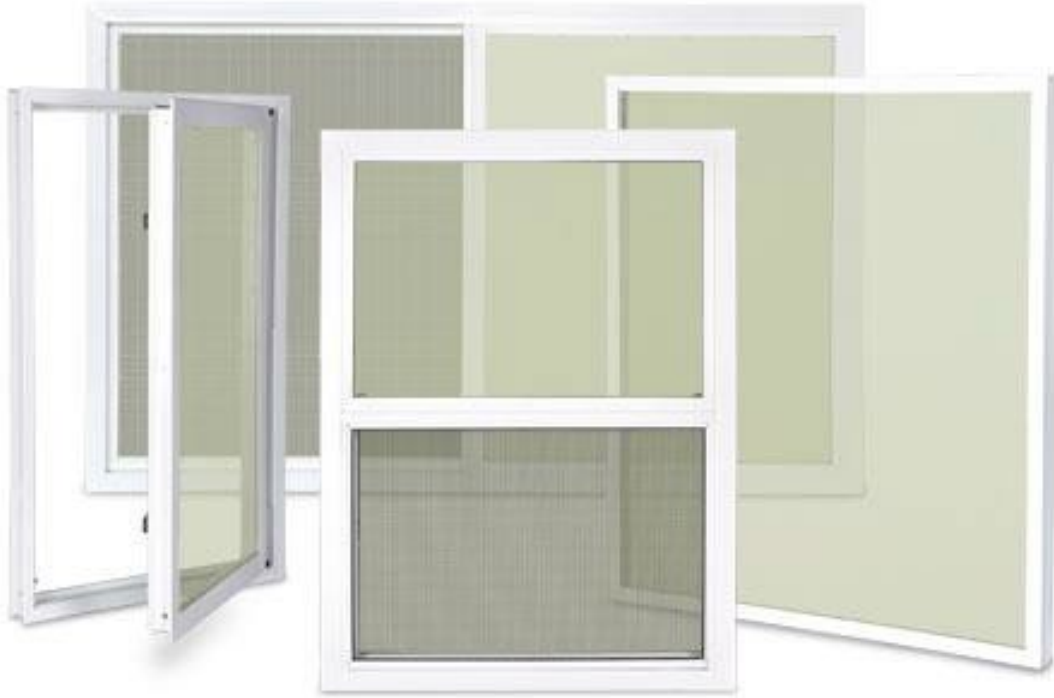
Figure 22: Fyre-Tec Fire Rated Window Styles. Image credit: fyre-tec.com, accessed March 21, 2023

This is a manufactured fire-rated steel window. The rolled steel sections have welded corners for strength and durability. The window frames have been listed by Underwriters Laboratories. Styles of windows include horizontal slider, single hung, fixed lite, awning, and casement. UL rated factory glazing options include clear ceramic 1 hour rated glass or ¼ inch wire glass with a 45-minute rating. These rated glazing types can be combined with Low-E glazing (to reduce UV and infrared light) in an insulated glass unit (IGU). Heat activated fusible links are standard on all operating windows which close the windows in the presence of fire. Horizontal sliding windows may also be equipped with a resettable device which may be activated by a fire or smoke alarm, computer, or another electrical signal.

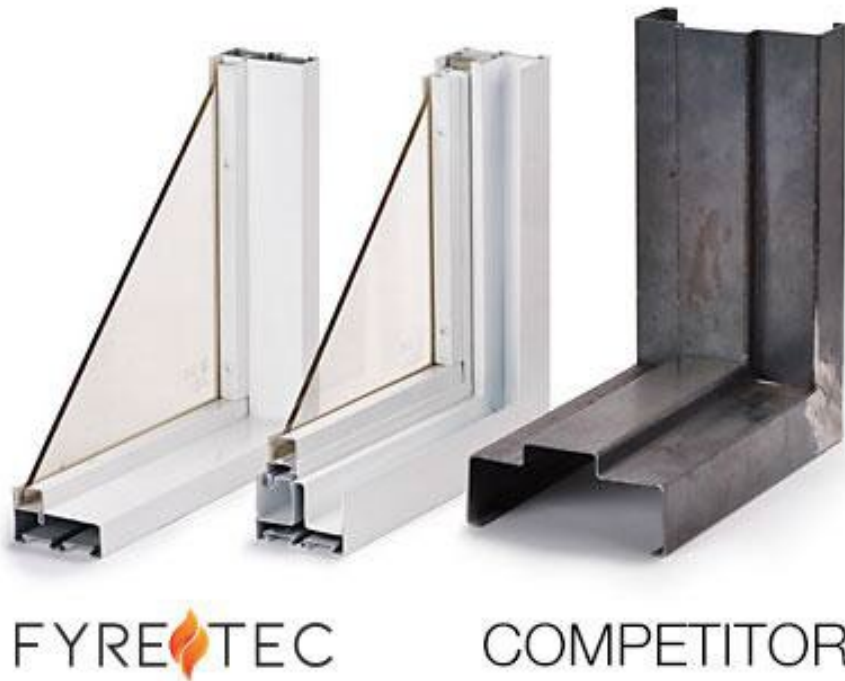
Figure 23: Fyre-Tec Fire Rated Window Sections Compared to Typical Rated Window Frame Construction. Image credit: fyre-tec.com, accessed March 21, 2023
