Chautauqua Wildfire Mitigation Plan Phase 2 Final Report

SHF Grant #2022-M2-001
Form+Works Project No. 22-040

Chautauqua Wildfire Mitigation Plan

Phase 2

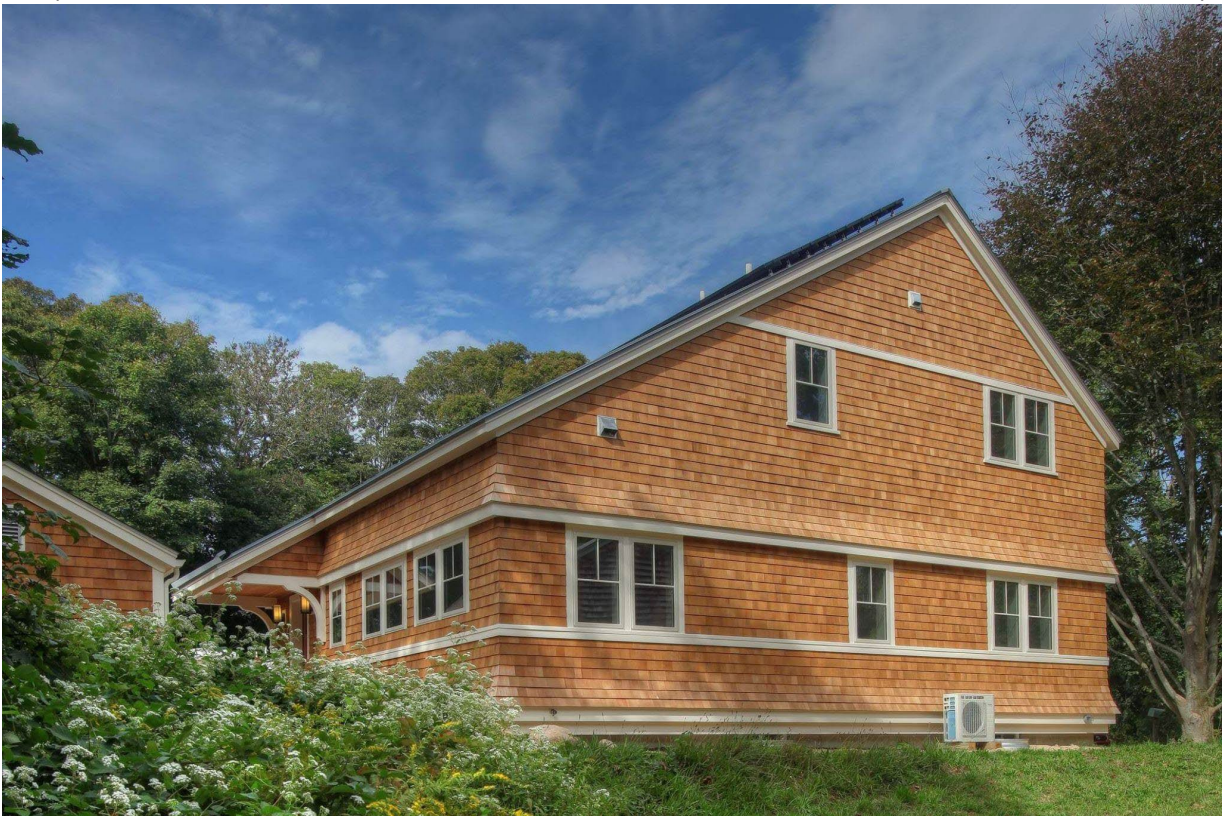
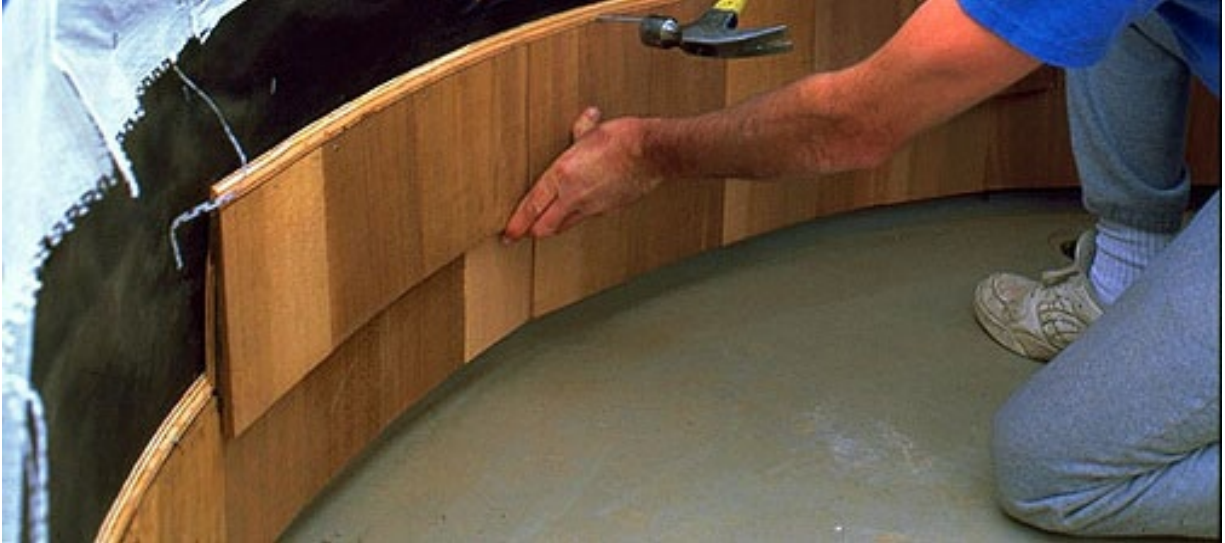
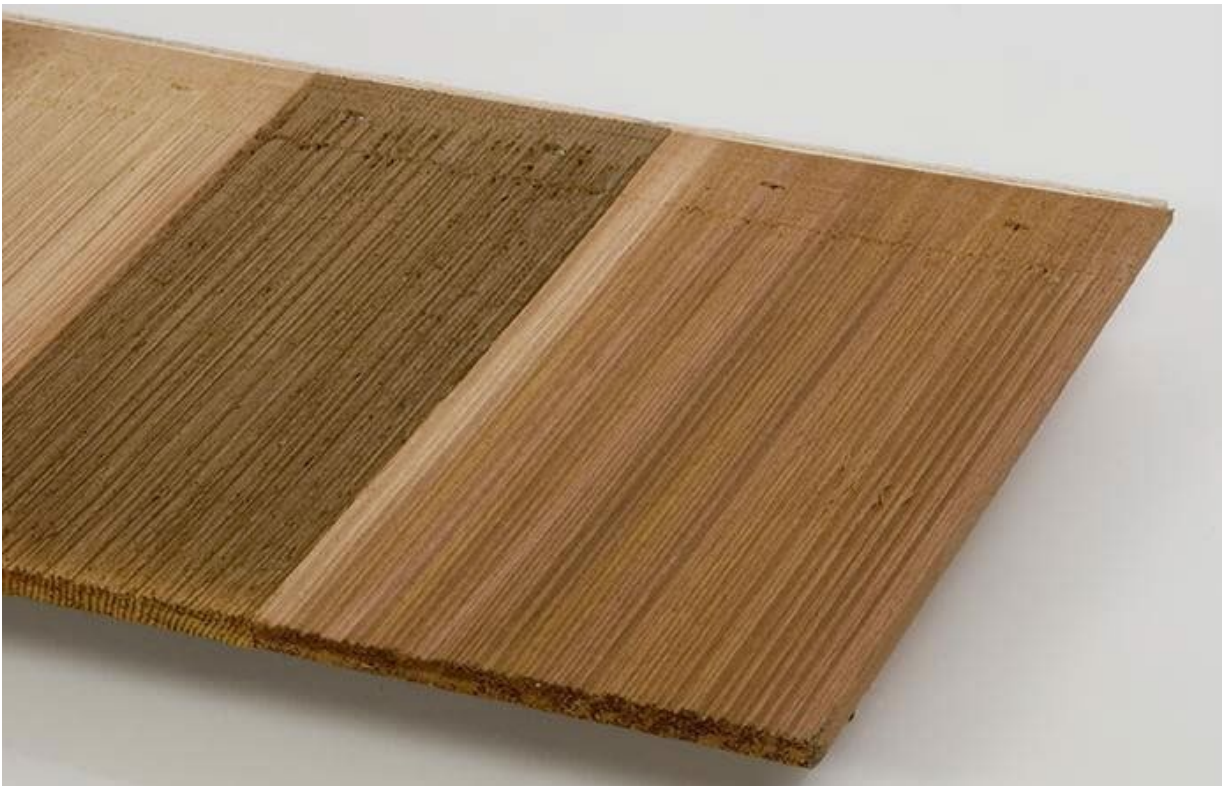
Figure 24: Cedar Valley Website Photo, Custom Massachusetts Home Installation, Accessed May 22, 2023

Figure 25: Cedar Valley Website Photo, Radius Panel Photo, Accessed May 22, 2023

Figure 26: Cedar Valley Website Photo, Custom Combed (Striated) Texture, Accessed May 22, 2023

Cedar Valley, a California Company, manufactures western red cedar shingle and shake siding panels for exterior walls. Their panelized system consists of shingles mounted to a fiberglass mat laminated onto a strong plywood backing. The system includes specialty customization options including matching corners and radius flares. Their products are CAL FIRE State Fire Marshal Wildland Urban Interface (WUI) approved for siding after undergoing the California SFM 12-7a-1 Fire Test. This test protocol involves a direct flame exposure at the base of a 4 foot by 8-foot wall sample at a heat output of 8535 BTU/min for a period of 10 minutes. The assembly is then observed for a period of 60 minutes for flaming or glowing on the unexposed side (Chapter 12-7A Materials and Construction Methods for Exterior Wildfire Exposure, 2023)

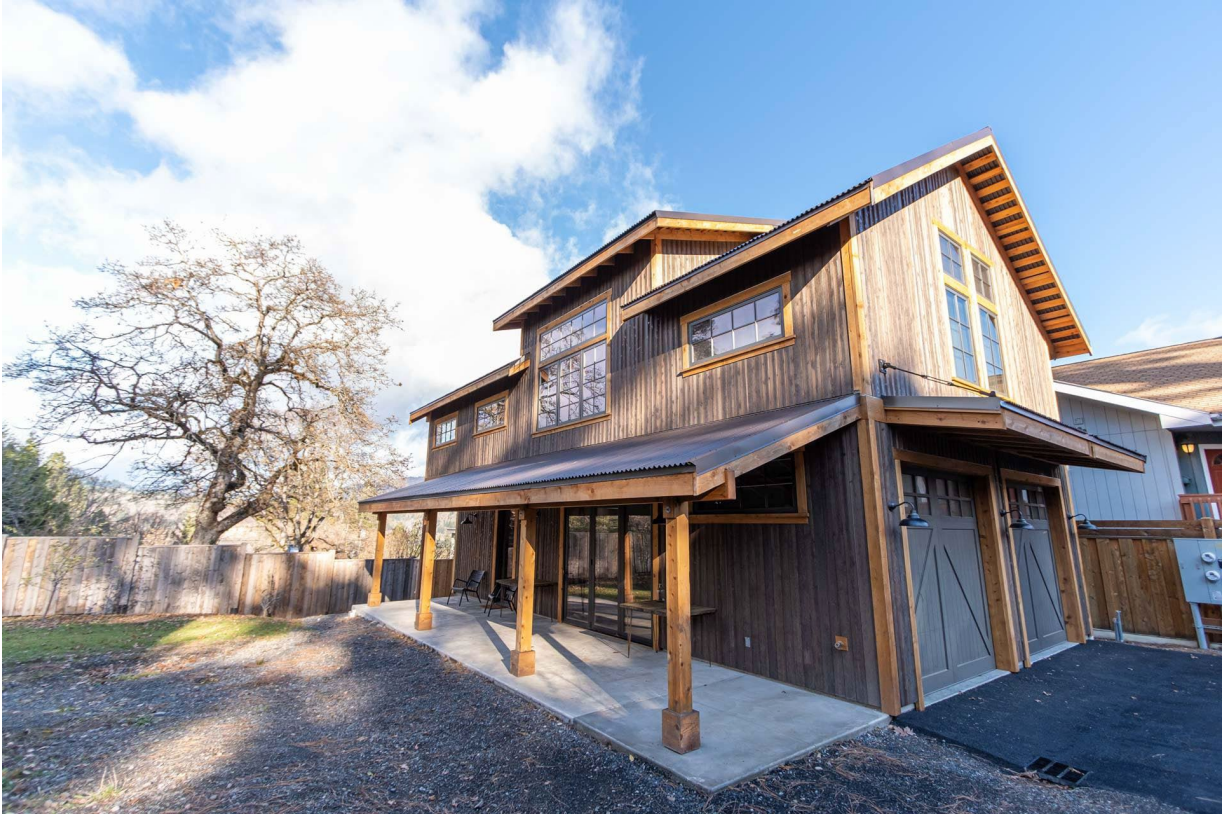
Figure 28: Hewn Website Project Photo, Accessed May 22, 2023

Hewn, a company in Oregon, manufactures a Class A Exterior Pressure Treated Fire Resistant Siding Product. The product aims to maintain the visual look and feel of exterior cedar siding that resists the spread of fire. An added benefit of their fire-resistant treatment process that they discuss is the aging process is slower and there is protection against ultraviolet degradation, providing for a longer lasting product. The testing they have undergone includes ASTM D-2898 (Standard Practice for Accelerated Weather of Fire-Retardant-Treated Wood for Fire Testing), ASTM D-84 (Standard Test Method for Surface Burning Characteristics of Building Materials) and their product has been verified by International Code Council (ICC ESR-1159 and ESL-1021, which are evaluations on multiple fire-retardant treated wood products, including SaferWood, Mataverde, etc.). Their products are available in standard nominal widths (1x4, 1x6, 1x8, 1x10 and 1x12) and have a thickness of 13/16 inches. The milling profiles available are Tongue and Groove or Shiplap. They have a Flame Spread Index of 25 or less, and a Smoke Developed Index of 45 or less. They have eleven standard finish options ranging from white, red, brown, and grey. There is the option of custom colors. The siding can be installed with the boards oriented vertically and horizontally. Following correspondence with the manufacturer, it became clear that their products are impregnated with Thermex FR, potentially by Chemco SaferWood although this is unclear, similar to other products included in this report.

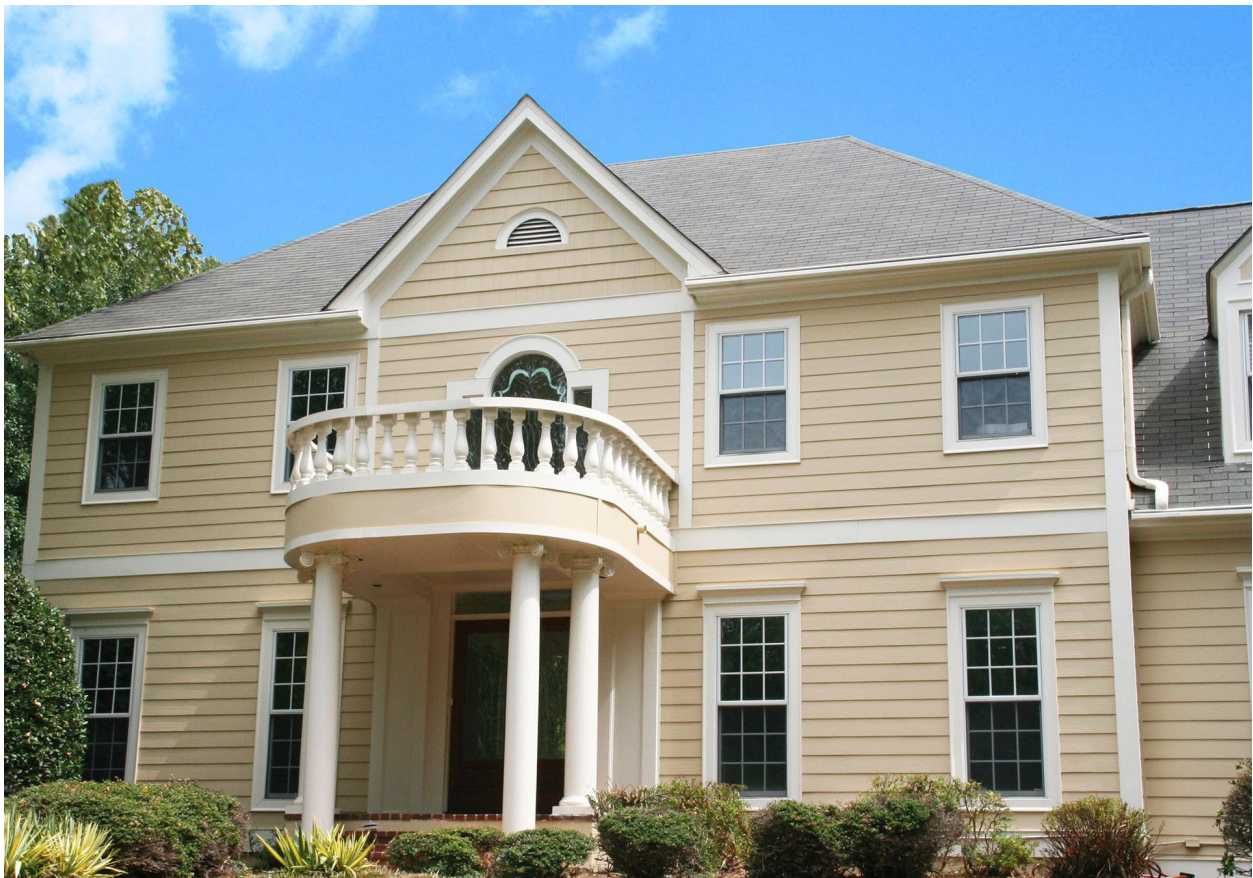
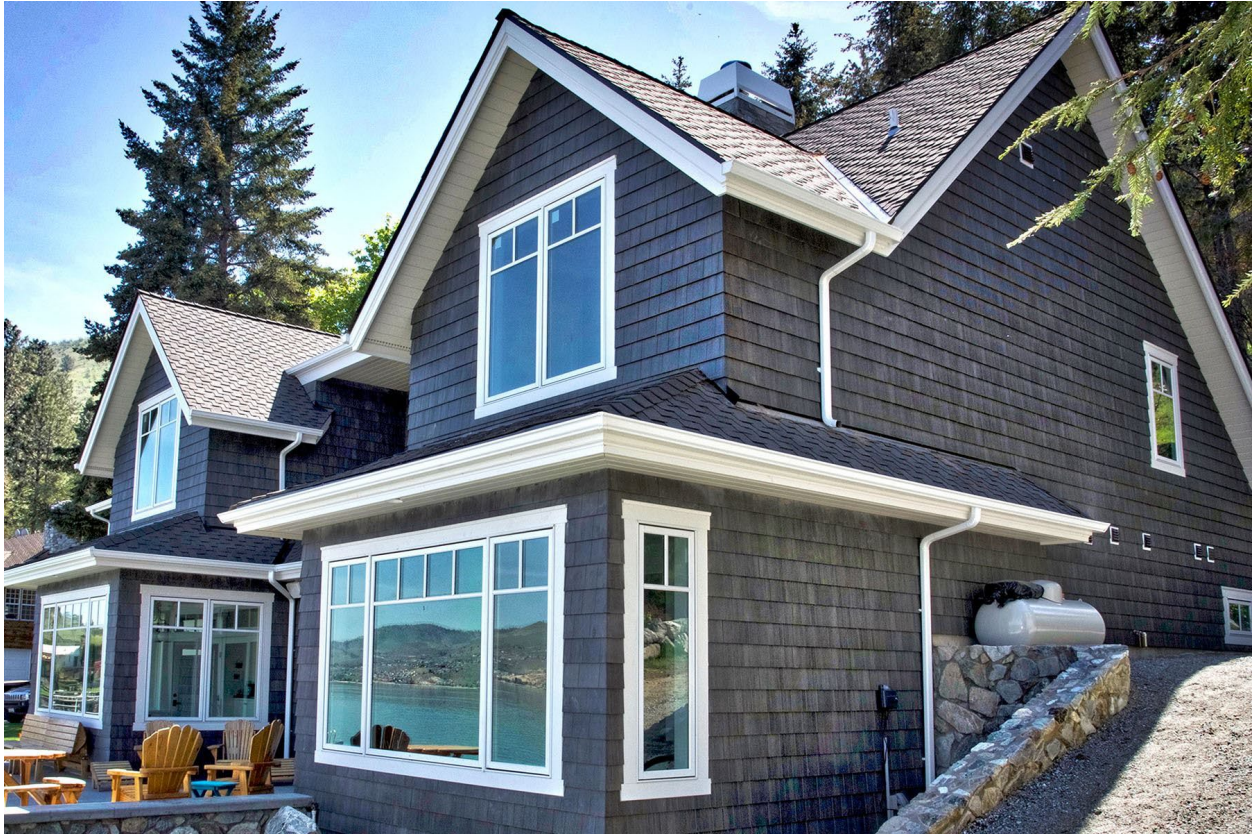
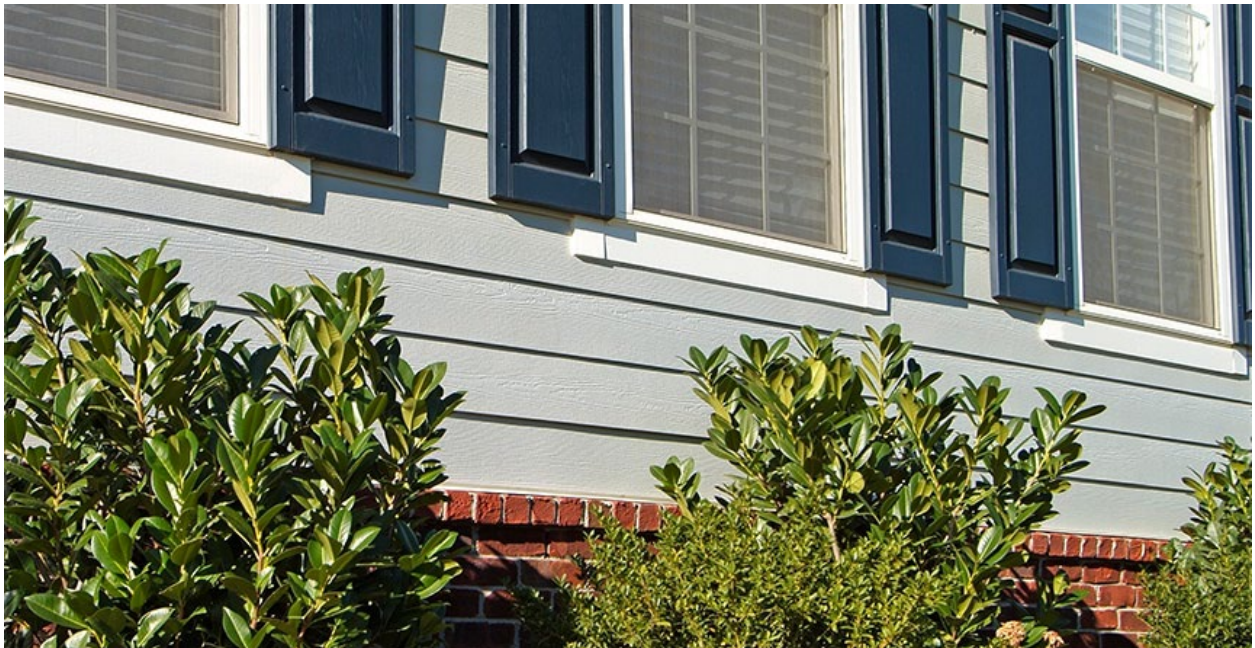
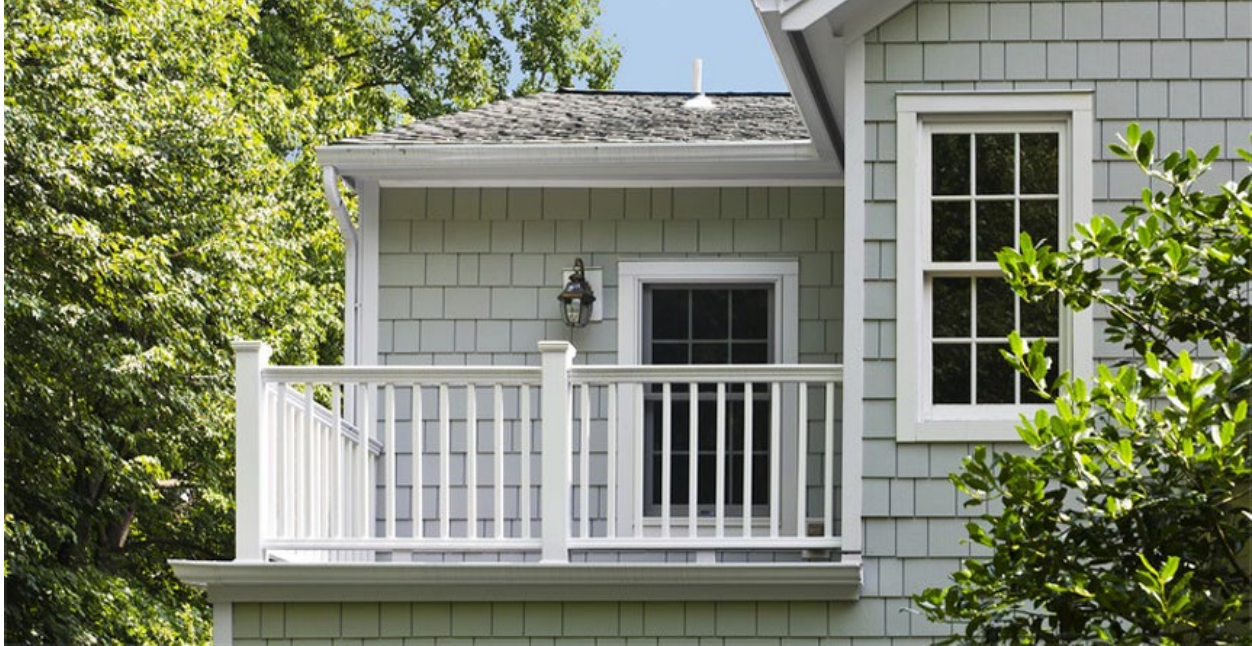
Figure 30: Nichiha Website Photo, Nichiboard Cedar (Nichiha, 2023)

Figure 31: Nichiha Website Photo, Sierra Premium Shake (Nichiha, 2023)

Figure 32: James Hardie Website Photo, Hardie Pank Lap Siding (James Hardie, 2023)

Figure 33: James Hardie Website Photo, Hardie Shingle Siding (James Hardie, 2023)

Fiber cement is a manufactured product made of cement, sand, cellulose, and other additives. It is advertised as a durable low-cost alternative to more expensive cladding options like wood, brick, or stone. There are various manufacturers on the market including: James Hardie, Nichiha Architectural Wall Panels, Equitone Panels, etc. Some manufacturers offer products that aim to mimic wood siding materials found on historic buildings like wood shakes, shingles, and horizontal clapboards.

Direct comparison of fiber cement siding is extremely difficult as the quality of each product line and manufacturer is not easily decipherable, especially when attempting to contrast it with historic wood siding. Fiber cement siding manufacturer's list benefits of their products such as "does not require regular repainting", "does not rot", "is insect resistant", "fireproof" and "performs exceptionally well in natural disasters". Manufacturer's recommendations on maintenance schedules also vary, however generally they recommend annual cleaning and then repainting every 10-15 years. Similarly, maintenance of wood siding is recommended to be cleaned annually with soapy water and a brush. In contrast, if painted, wood siding may require repainting in as little as 3 years and up to 15 years. The maintenance schedule for wood siding is highly dependent on the color (darker colors fade more quickly than lighter colors) and the quality of paint (higher quality paint performs better for a longer duration). It would be prudent to consider that a dark paint on fiber cement siding would degrade at a fairly similar rate as it would on wood siding, considering they would be exposed to identical sun and weather patterns. Moisture performance of fiber cement siding is questionable. Fiber cement siding has been known to hold moisture and even mold, although higher quality manufactured products may have addressed some of these problems. Wood siding does swell when exposed to moisture, and extended duration of exposure results in rot, but wood itself is typically a breathable material that will, in most cases - if the moisture is mitigated/managed - dry back out and reset to its original profile. The biggest consideration for fiber cement siding in comparison to wood siding is the visual and material compatibility. Although manufacturers advertise their ability to mimic historic wood profiles and dimensions, the smallest exposure available at the time of this report is 4 inches (from HardiePlank) and all board lengths are 12 feet. A manufacturer stamped wood texture on a fiber cement siding board also visually differs from a real wood product. Consideration would be needed based on specific building design features on whether a visual match is achievable with a fiber cement product.

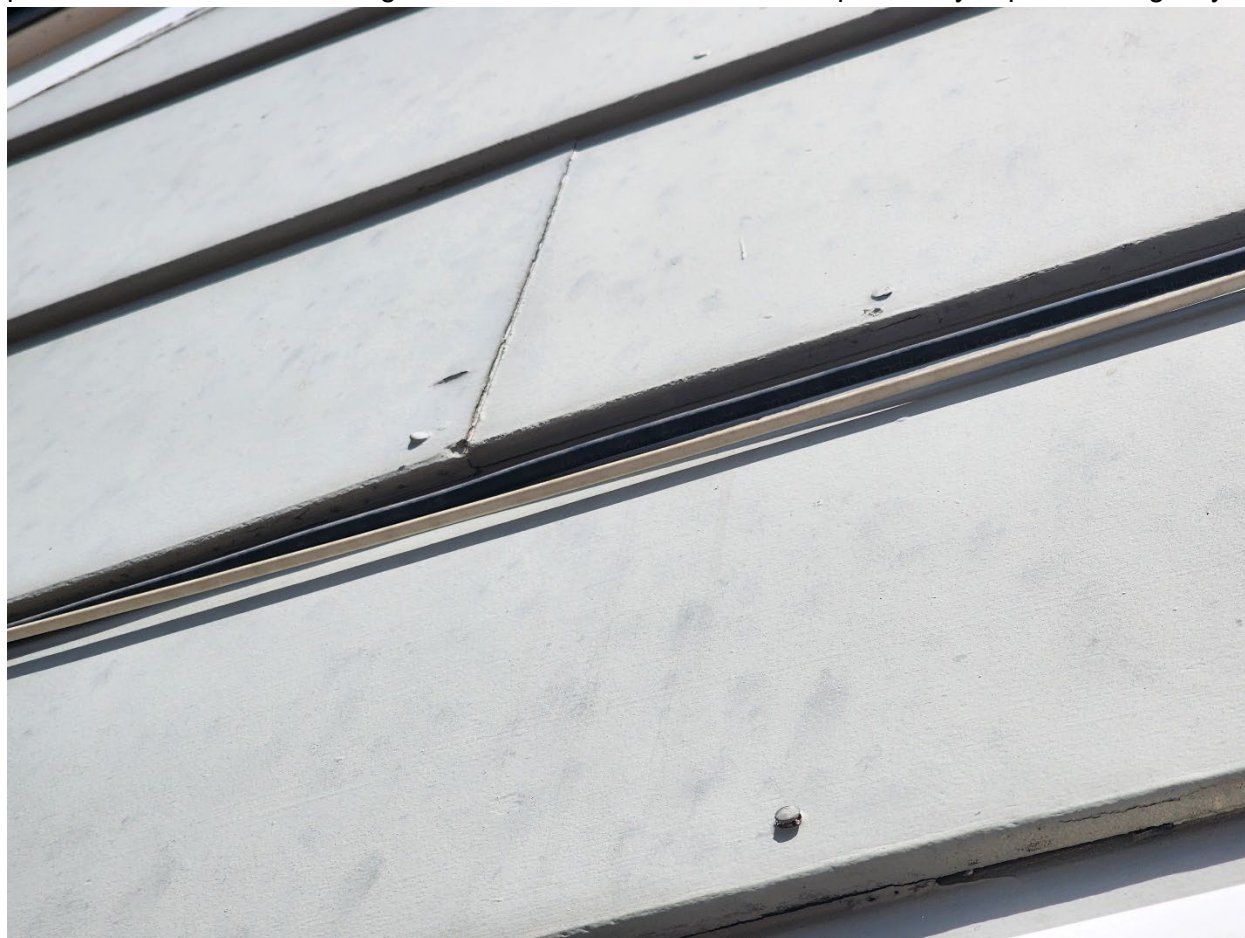
Figure 34: West Wall of 1957 Ranch in Colorado, Nails Visibly Working Their Way Out of Fiber Cement Siding (Lord, 2023)

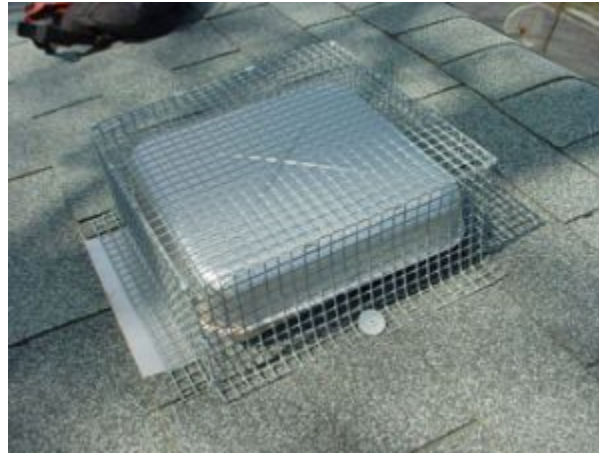
Figure 37: Roof Vent with Retrofitted Wire Mesh Cover (Roof Vent Screens Installation, 2023)

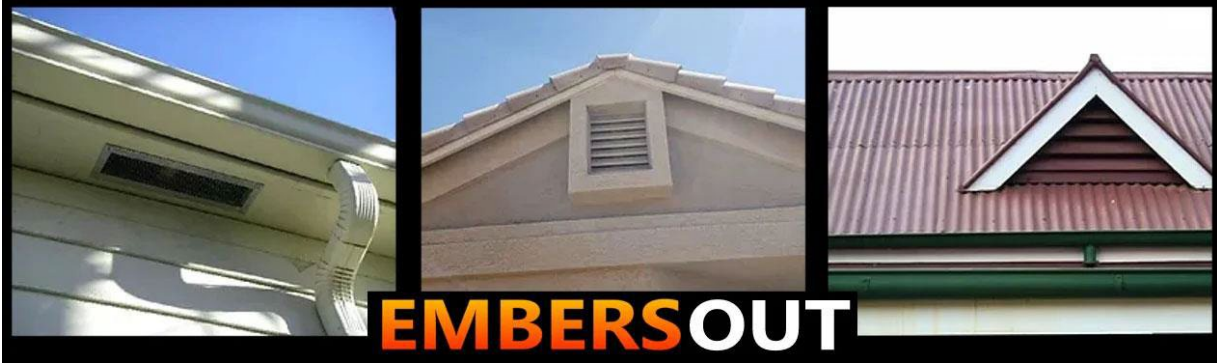
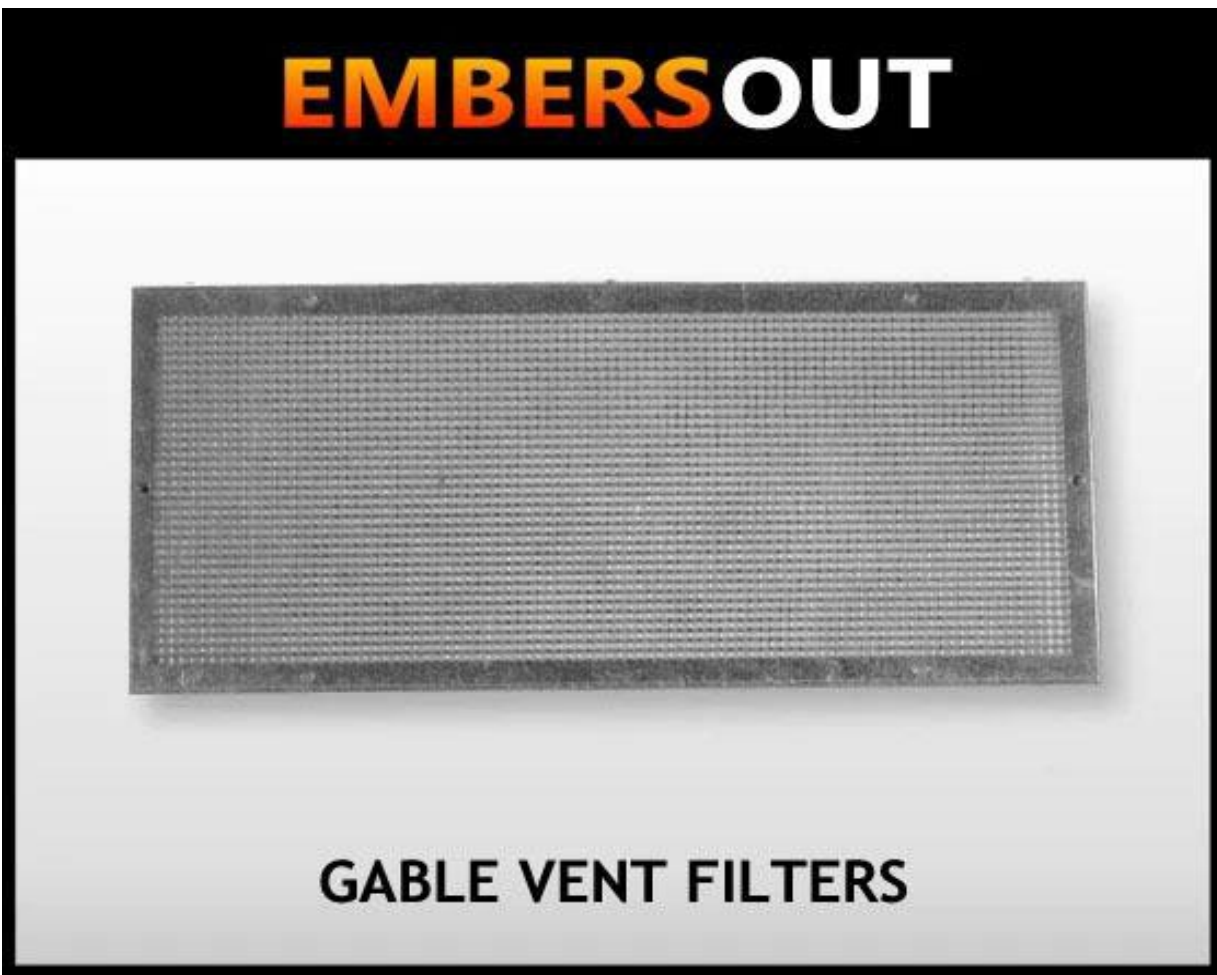
Figure 38: Photo from Embers Out Website of Retrofitted Vent Applications, Accessed May 22, 2023

Figure 39: Photo from Embers Out Website of Gable Vent Filter, Accessed May 22, 2023

Embers Out is a company in California that developed protective vent filters that can be installed over existing vents in order to stop embers from entering the building and restricting access to direct flames. Additional benefits the manufacturer advertises are that their vents restrict insects and rodents, dust and debris, wind driven rain, snowpack penetration, and wind. Their company lists the following features: they are CAL FIRE approved, made in America, have a lifetime guarantee, and are impervious to corrosion. Their products are paintable, so once installed they can be painted to match a building's exterior. They meet the ASTM EE2886/E2286M-14 standard, which is the American Society for Testing and Materials (ASTM) Standard Test for Evaluating the Ability of Exterior Vents to Resist the Entry of Embers and Direct Flame Impingement. A video on the Embers Out Website shows the testing with flying embers and direct flames with cotton pads on the opposite side of the vent. In both cases, the cotton pads did not ignite.

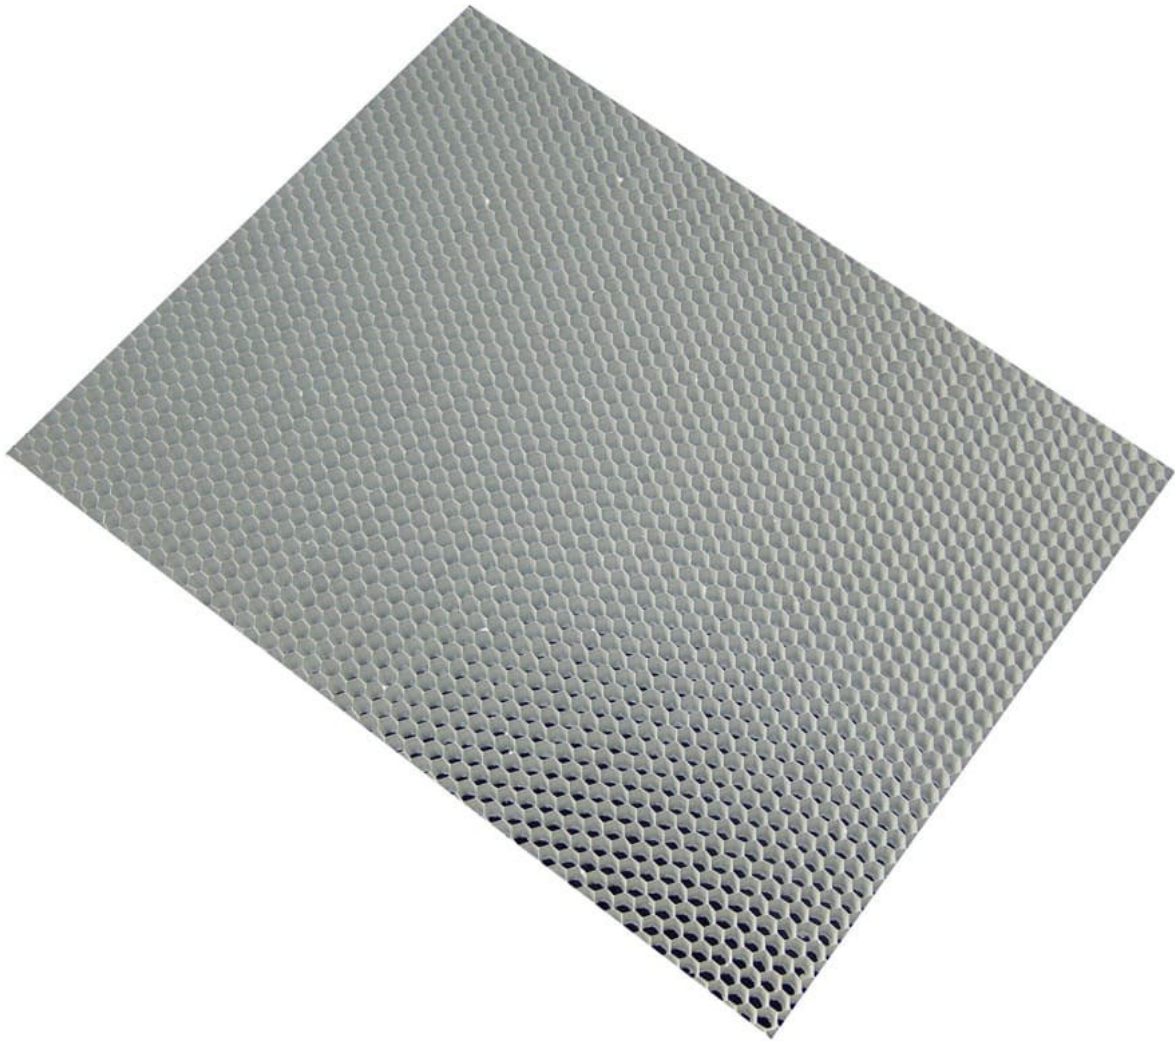
Figure 40: Vulcan Vent Honeycomb Matrix, Accessed May 22, 2023

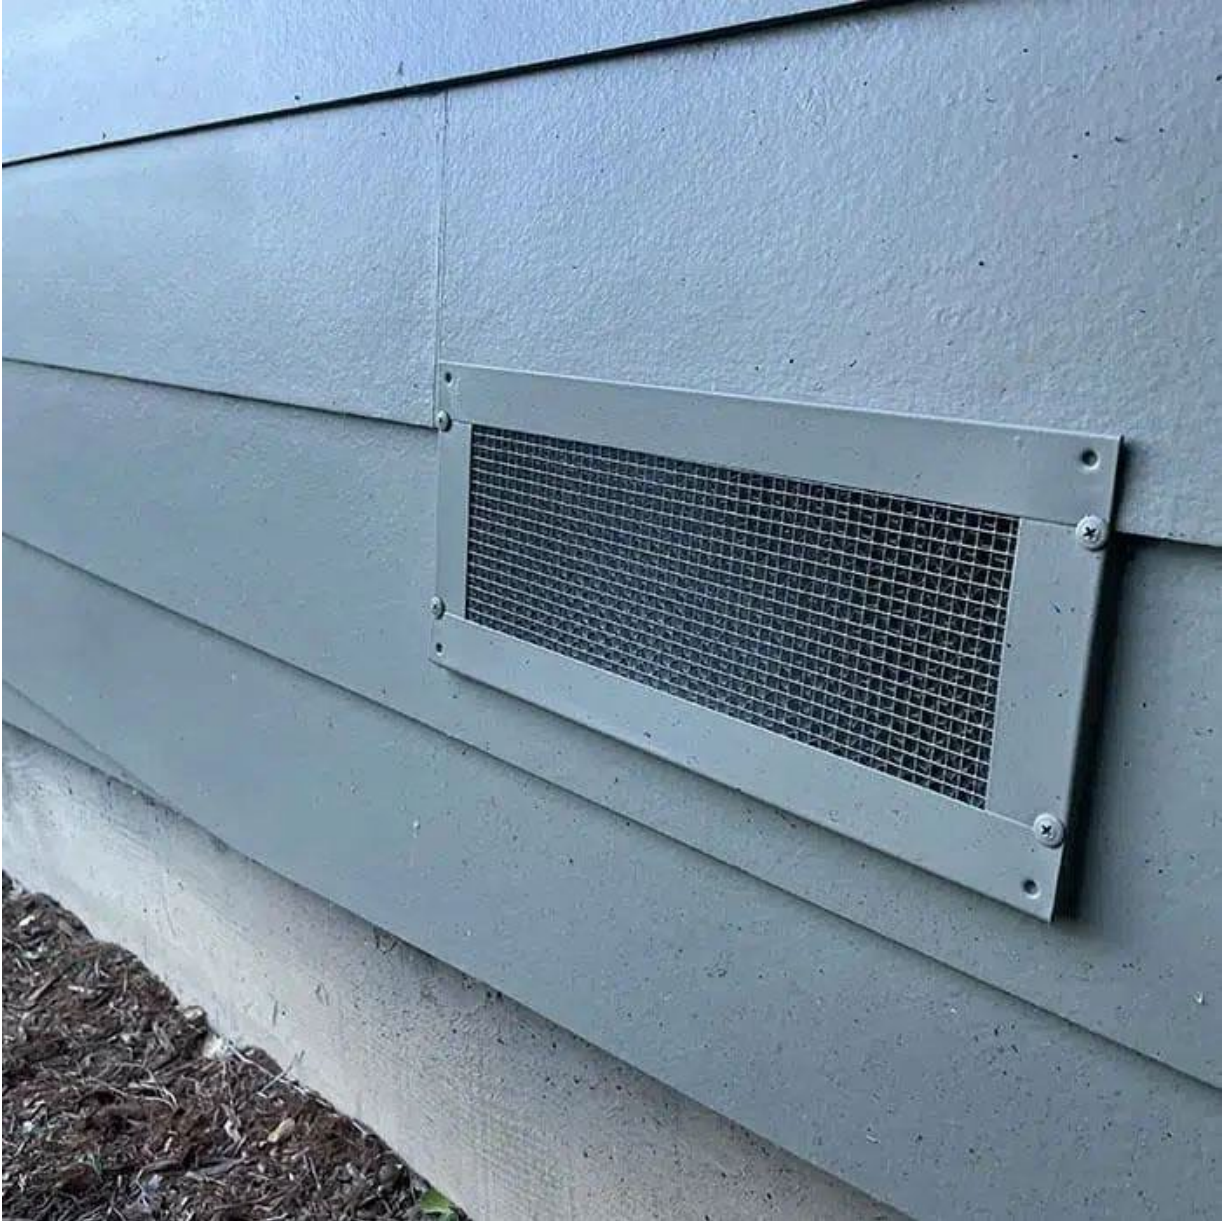
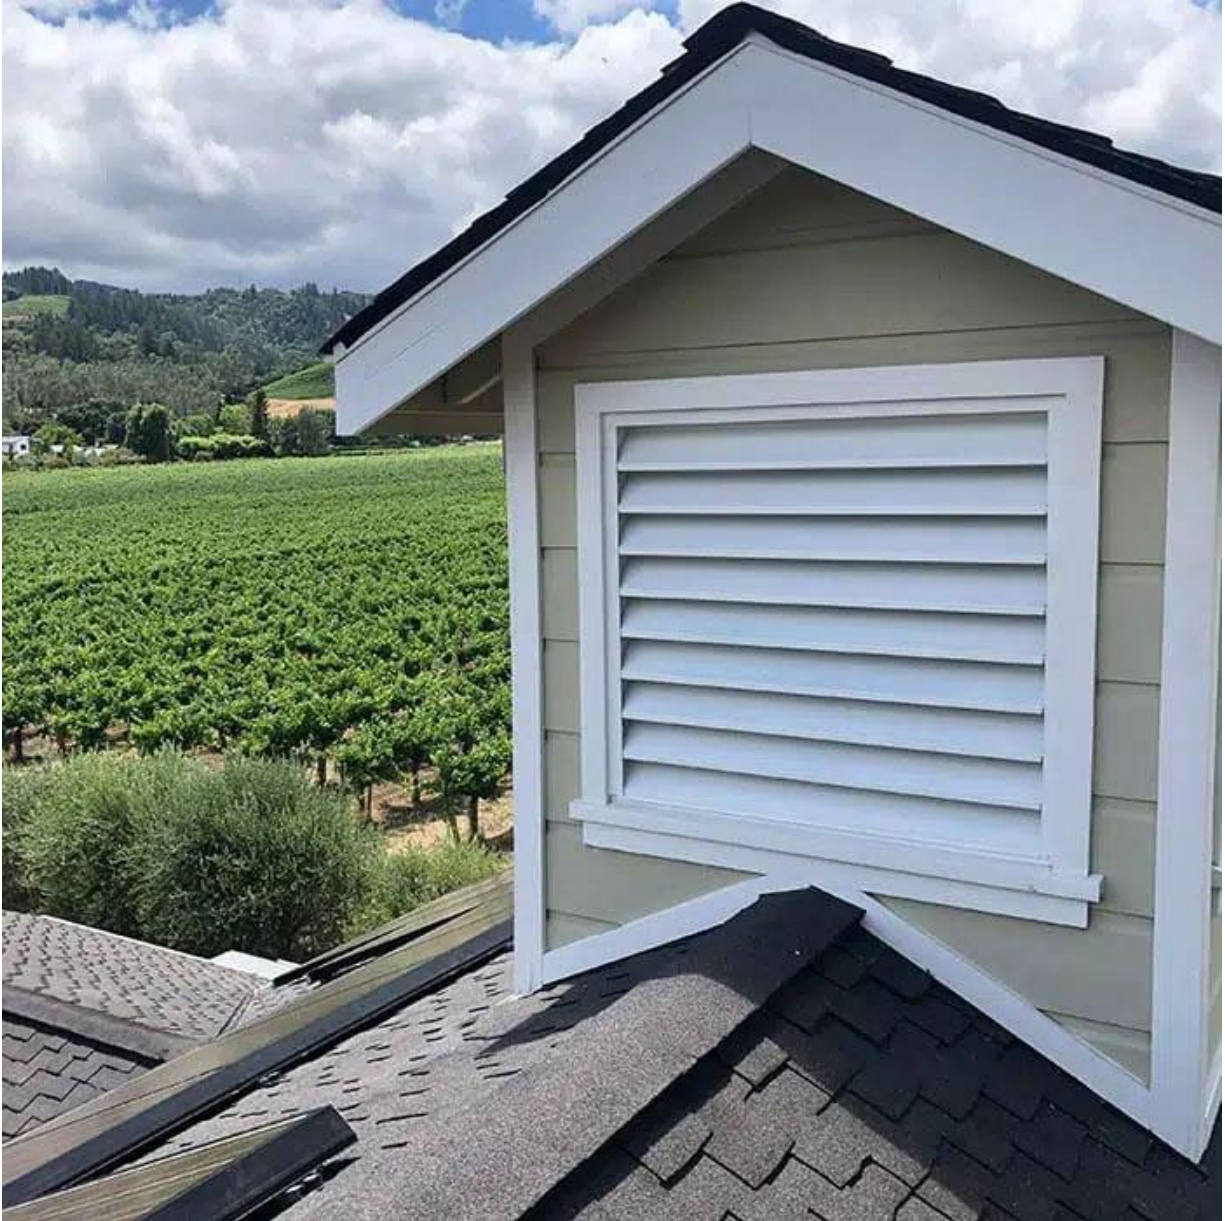
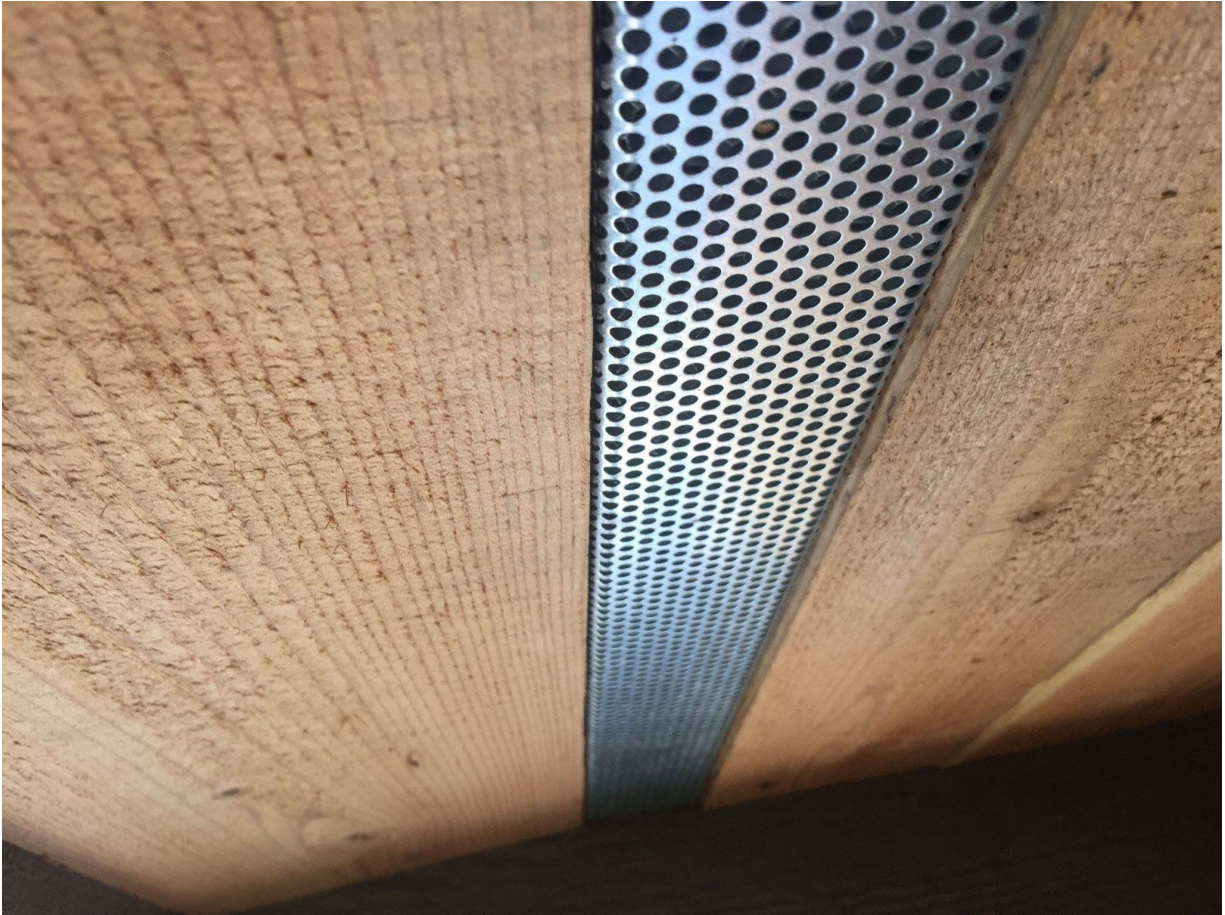
Figure 41: Vulcan Vent Foundation Vent, Accessed May 22, 2023

Figure 42: Vulcan Vent Gable Vent, Accessed May 22, 2023

Figure 43: Vulcan Vent Soffit Vent, Accessed May 22, 2023

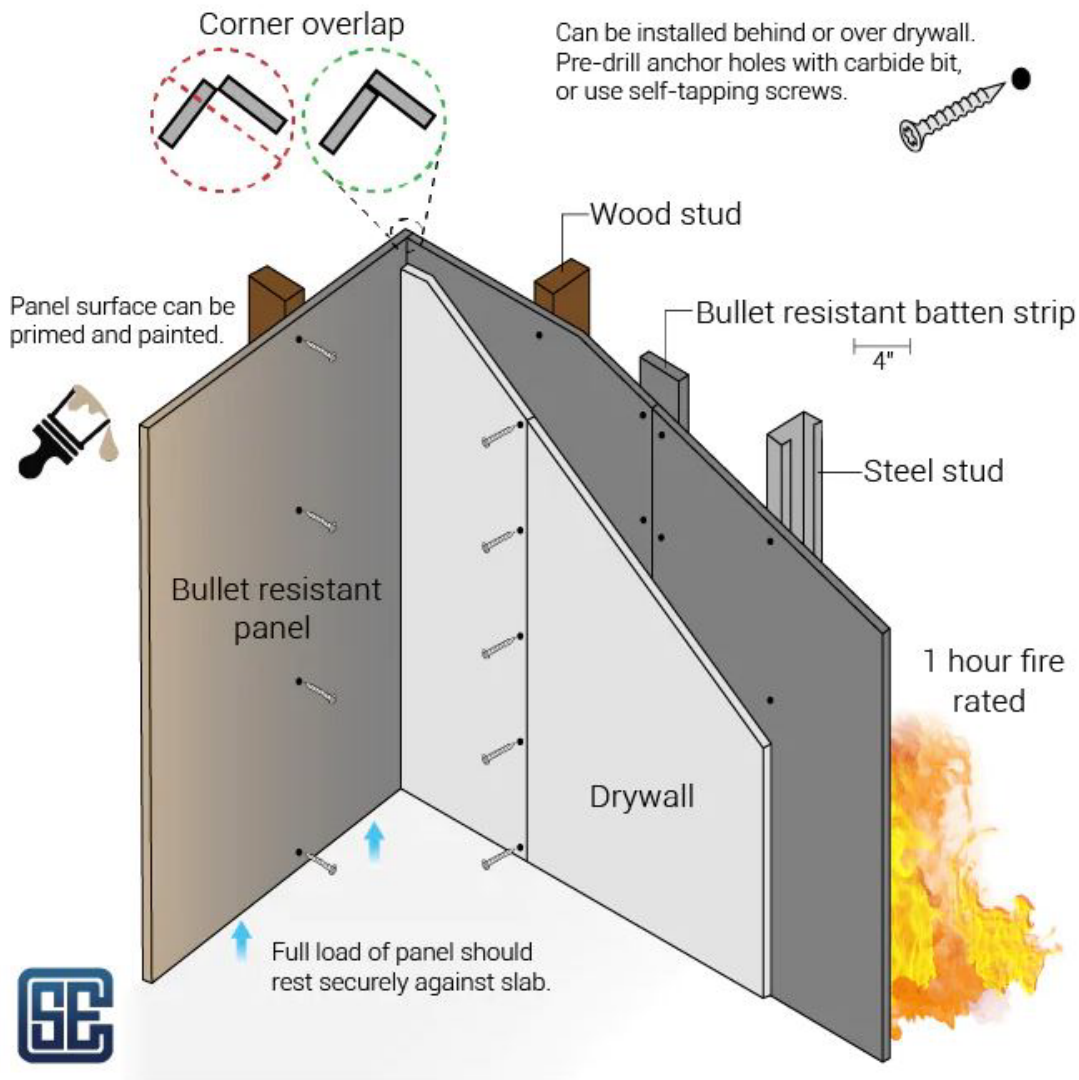
Figure 45: Armortex Installation Diagram, Accessed May 23, 2023

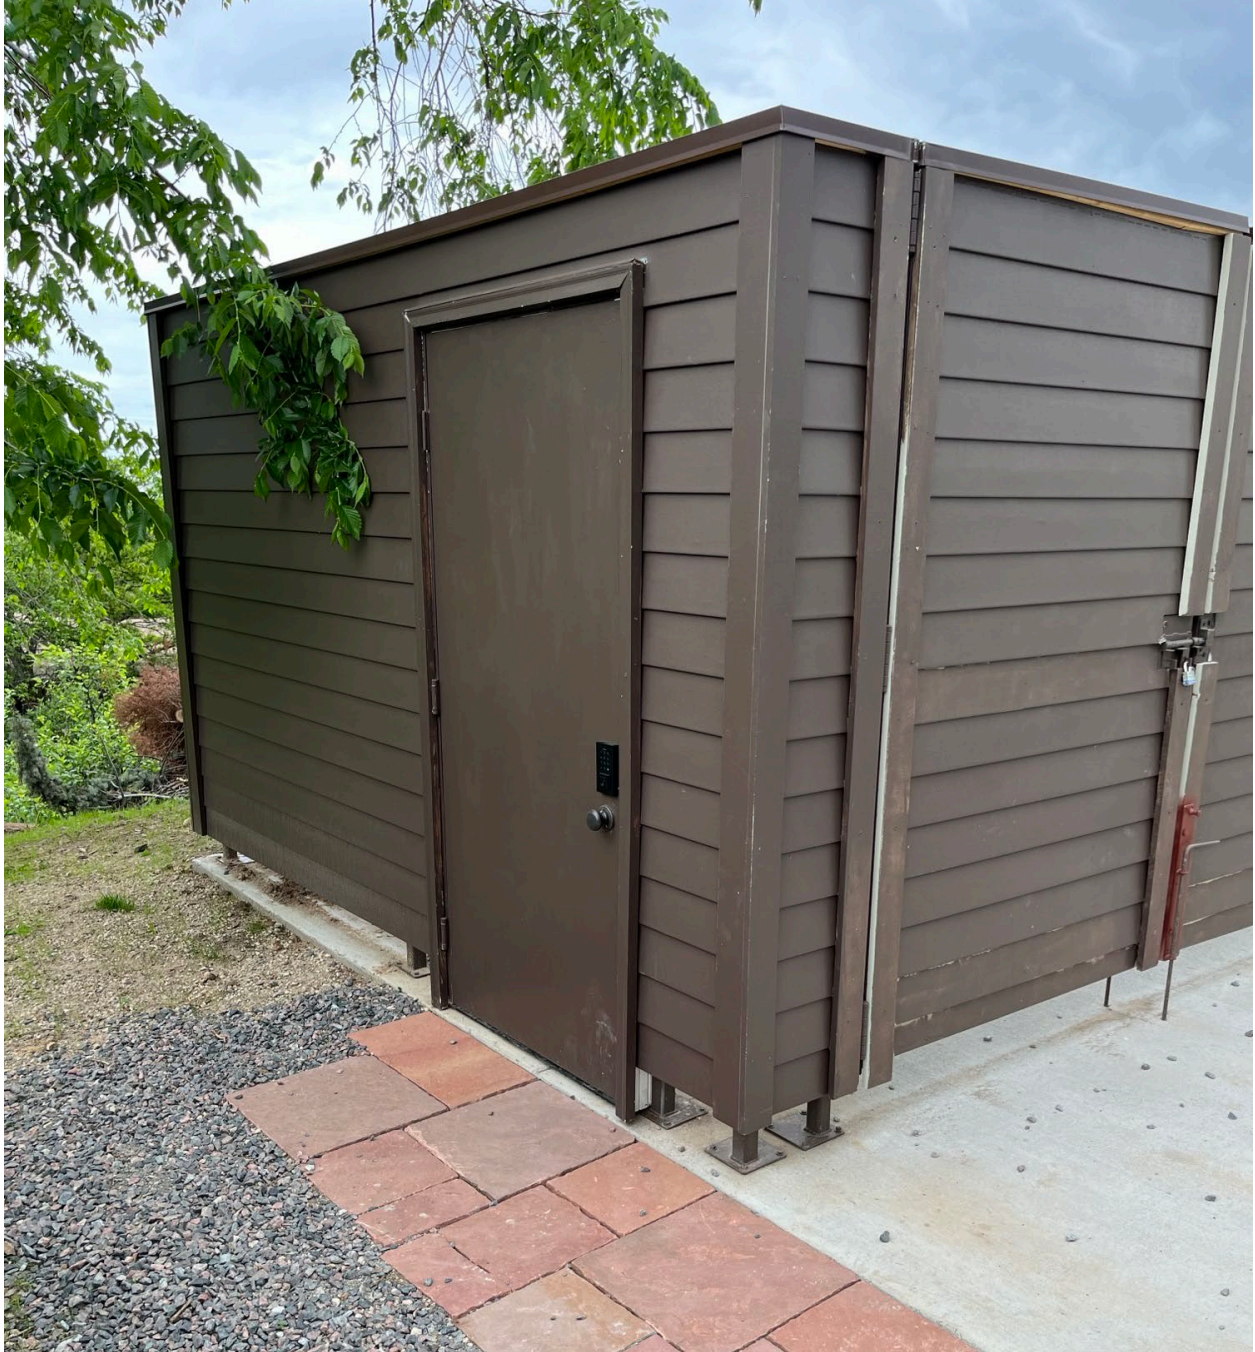
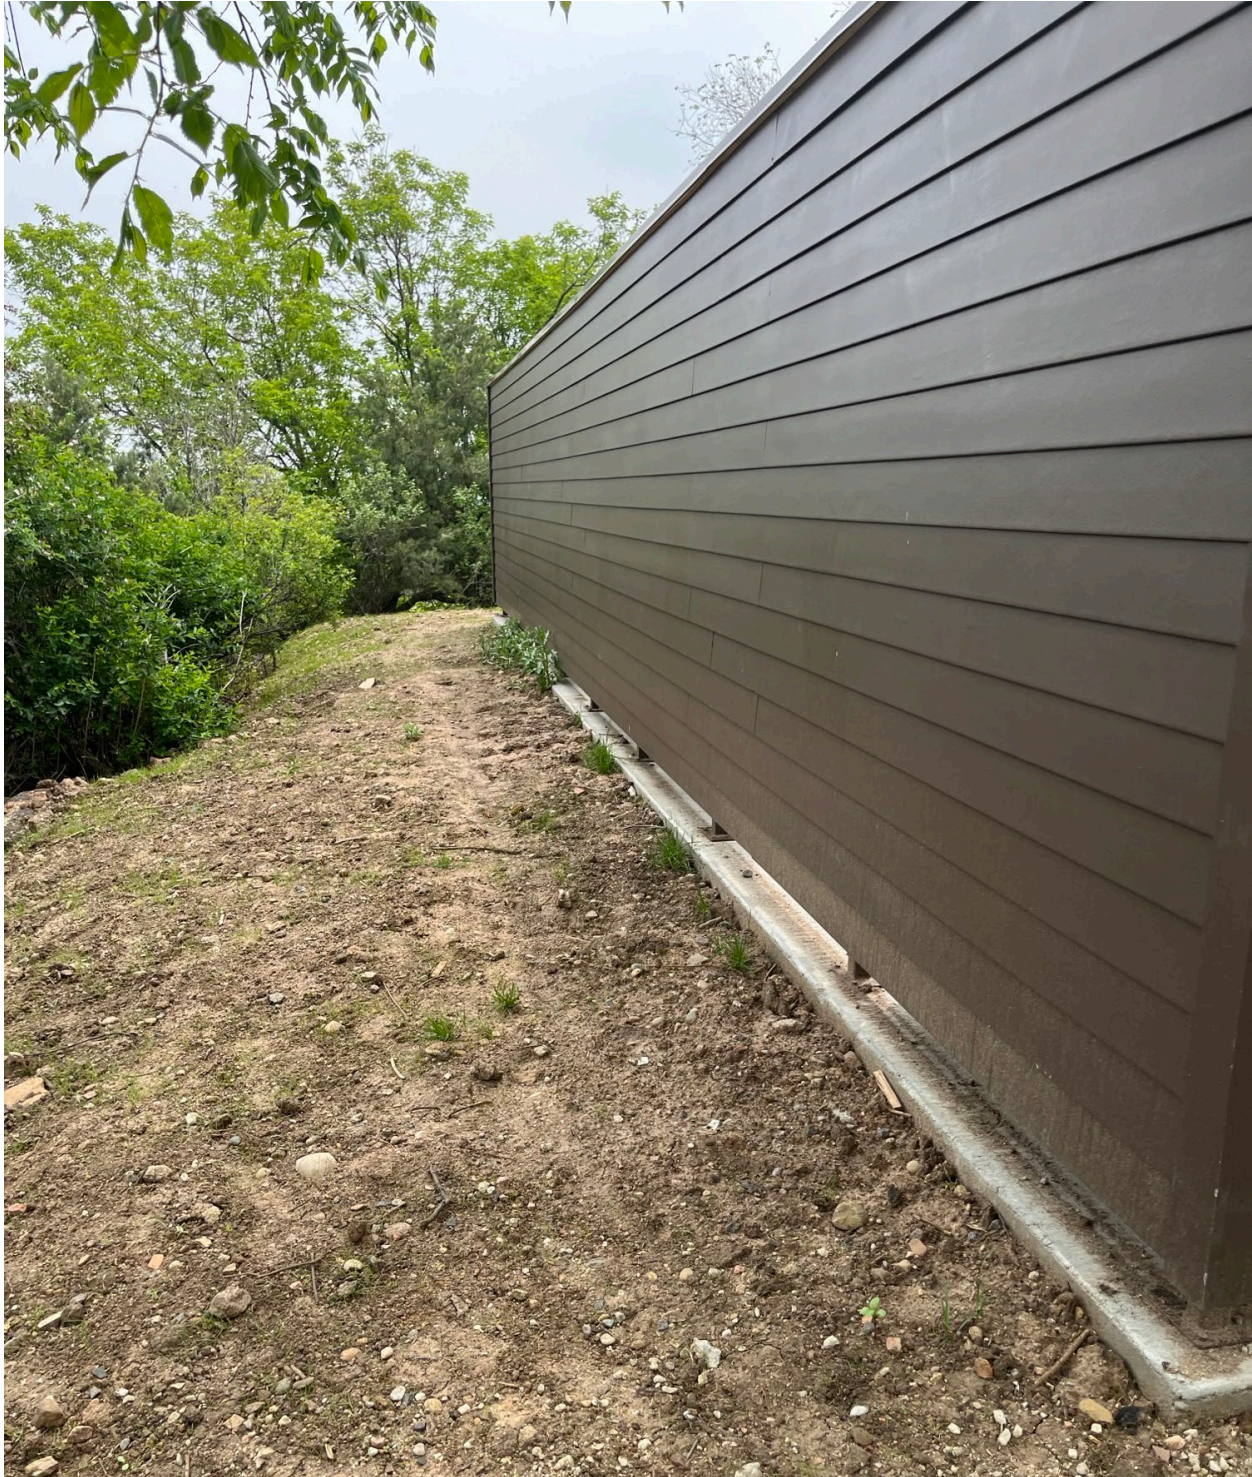
Figure 46: Fiber Cement Siding approved at new Chautauqua Trash Enclosure

Figure 47: Chautauqua Trash Enclosure with Fiber Cement Siding

The use of fiber cement siding at Chautauqua was approved for the new trash enclosure constructed in the district, see Figure 46 and Figure 47. However, it would not be recommended as a treatment for replacement of historic wood cladding and trim on any of Chautauqua's contributing buildings due to it not being a visually compatible material and questions on performance. Wholesale replacement of historic wood cladding and trim does not currently meet the SOI Standard, but similarly to fire-retardant treated wood, further consideration specific to adaptation for historic structures in wildfire areas may be warranted.
