Chautauqua Wildfire Mitigation Plan Phase 2 Final Report

SHF Grant #2022-M2-001
Form+Works Project No. 22-040

Chautauqua Wildfire Mitigation Plan

Phase 2

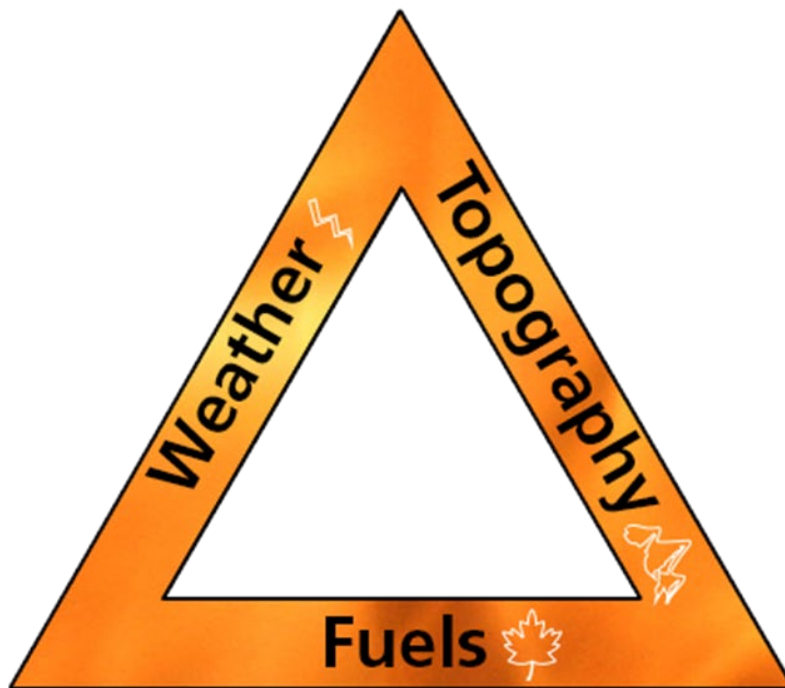
Figure 1. The fire triangle.

Fuels, weather, and topography are the key factors in wildland fire behavior. As shown in the well-known fire triangle in **Figure 1**, it is the interaction of these three variables that responders must address when allocating resources to protect life and property.

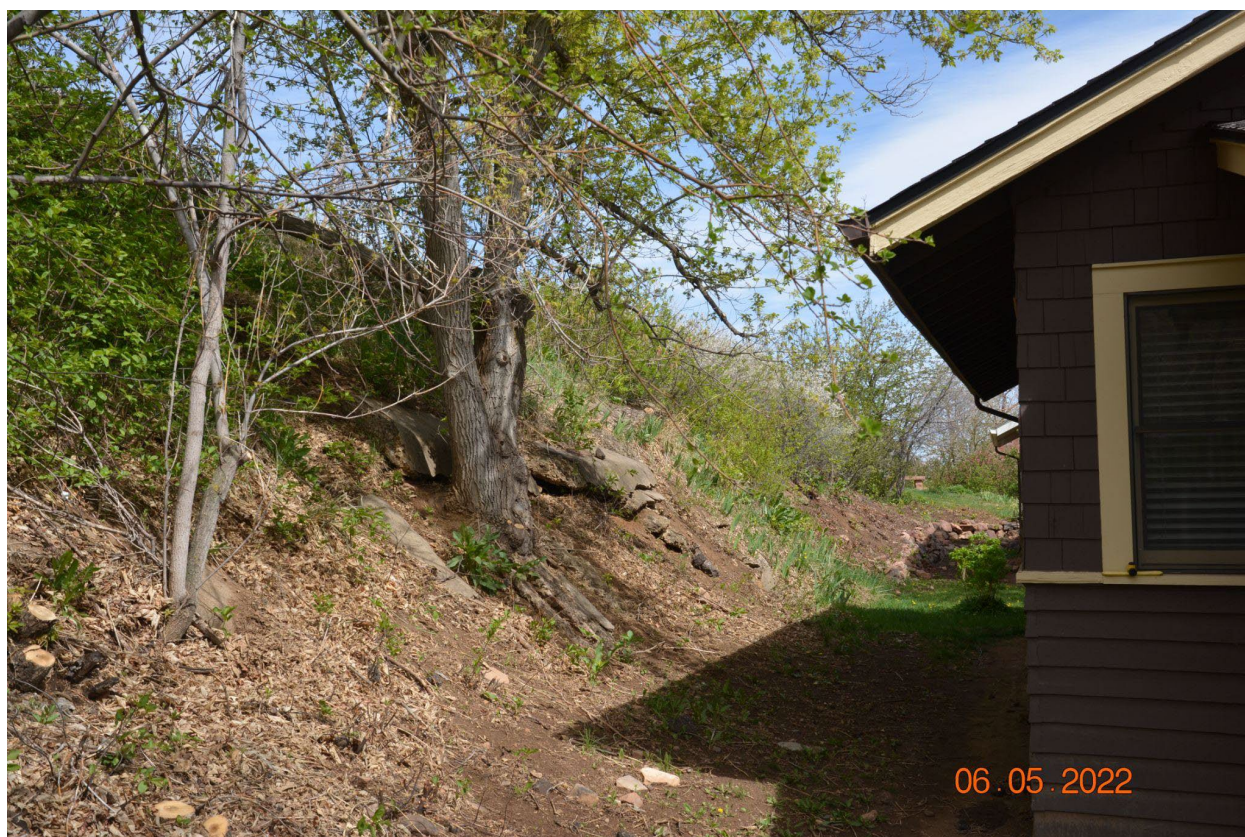
Figure 2. Western boundary where fuels mitigation has been conducted. Note there has been a reduction in fuel load and thinning of some of the horizontal and vertical continuity. However, enough vegetation remains, mostly shrubs, to allow for spread of a fire from the west onto Chautauqua property.

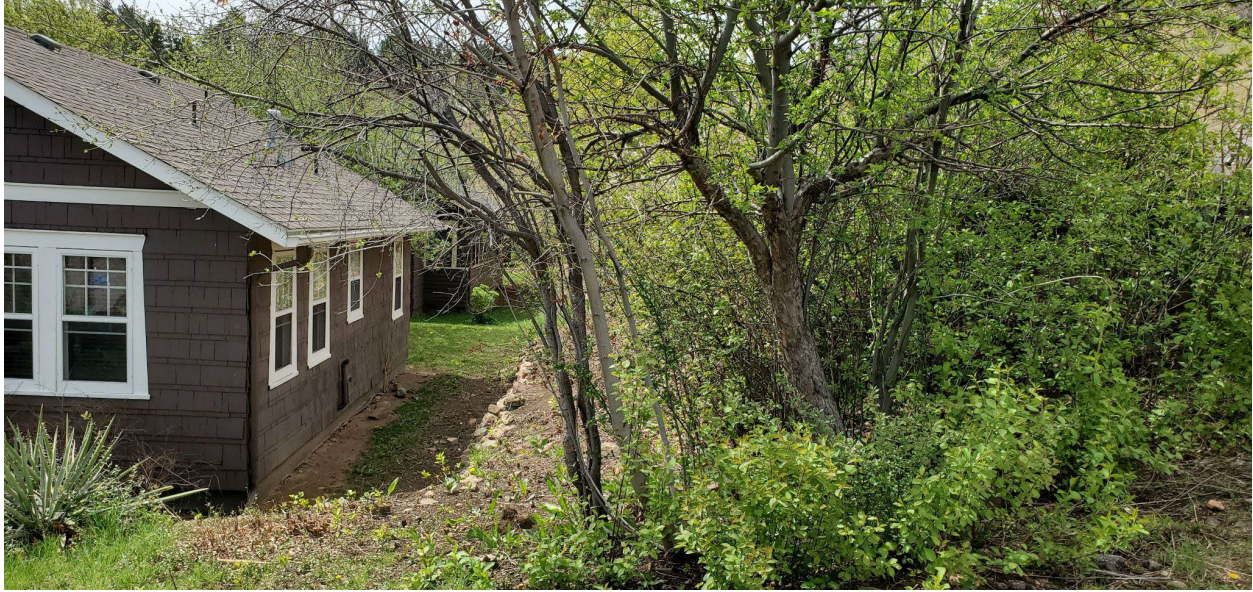
Figure 3. Western boundary where fuels mitigation is yet to be conducted. Note the horizontal and vertical continuity of the vegetation which would allow for a fire to easily spread.

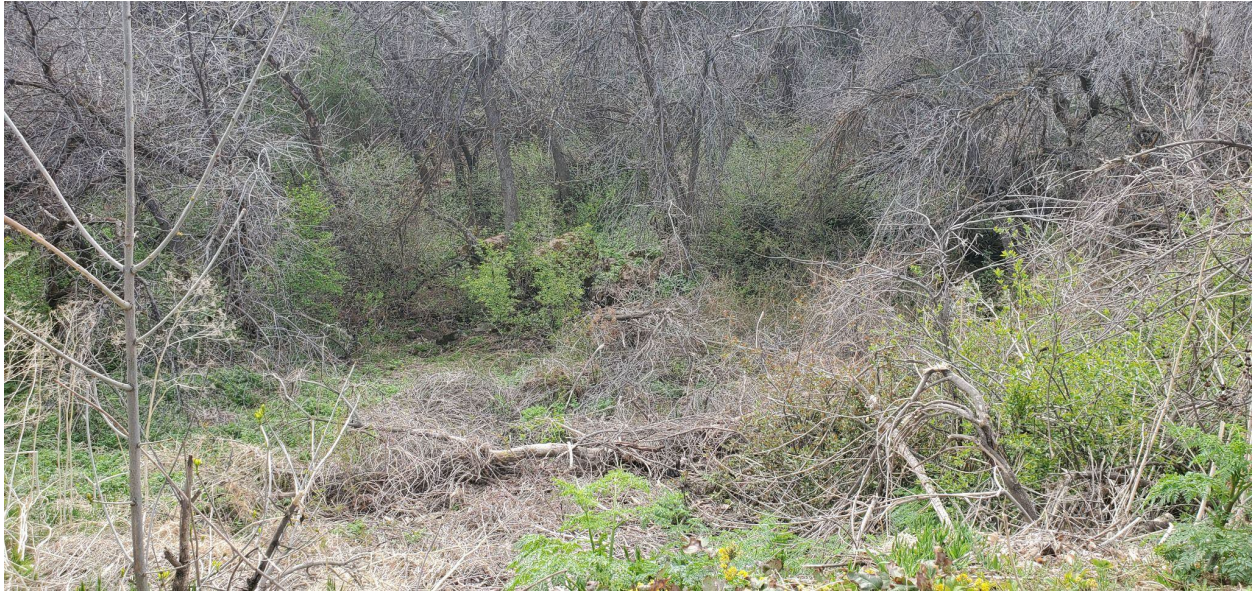
Figure 4. OSMP property on eastern boundary where fuel mitigation work was done. However, this area would benefit from further removal of vegetation to reduce horizontal and vertical continuity as well as fuel load.

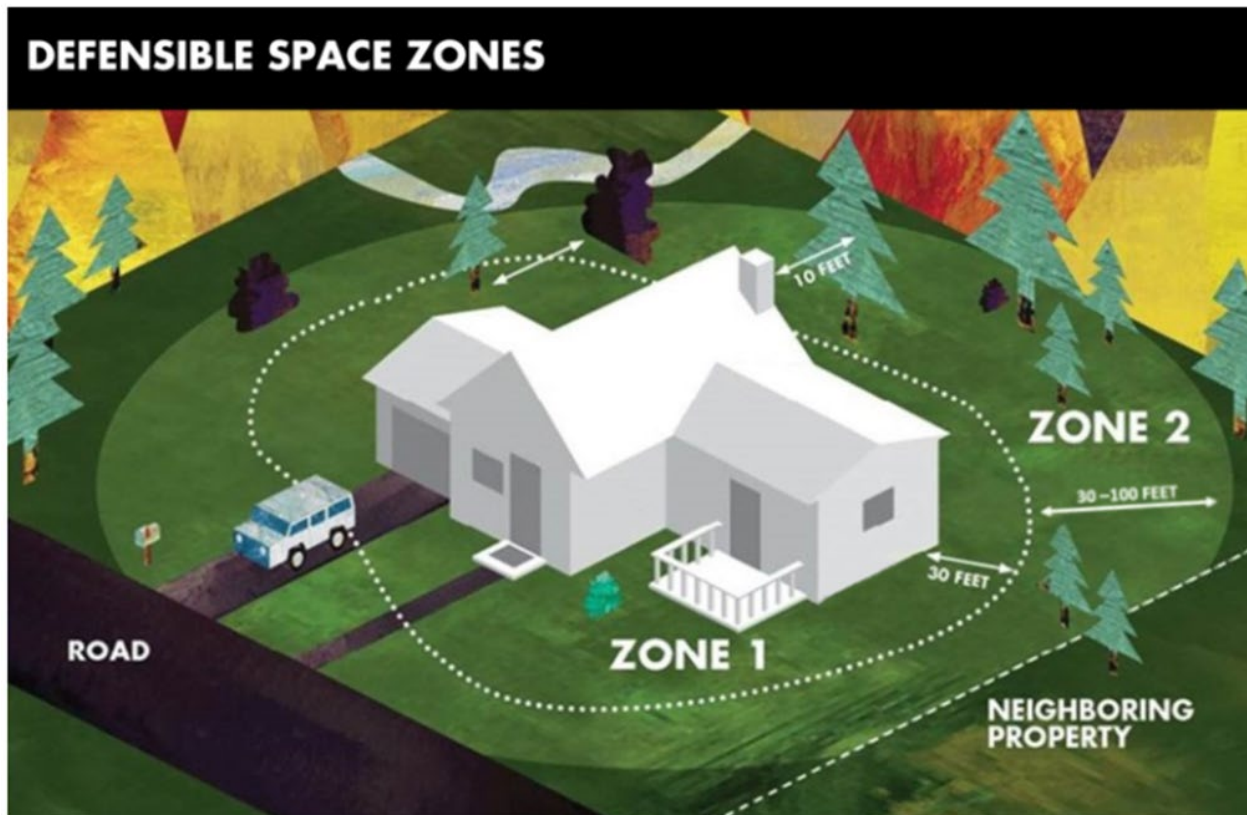
Figure 5. Idealized defensible space that is recommended around a single structure.

Defensible space around a structure to reduce the likelihood of significant damage or loss of the structure is a concept that has been promoted for decades, along with an understanding of the role of building materials on the risk of damage or loss due to fire. **Figures 5 and 6** show examples of what are promoted as best practices for establishing defensible space around residential structures in fire-prone areas. These recommendations are good guidance for many residential structures or other buildings in the WUI but not so appropriate for Chautauqua. The designation as a National Historic Landmark needs to be balanced with standard recommended mitigation practices. As is seen in **Figure 8**, it is not possible to achieve the recommended defensible space between buildings at Chautauqua because of the close spacing of structures.

These examples of defensible space will, generally, not work well within Chautauqua property. They will be effective around the perimeter, but the cottages and other structures are too close to allow for the recommended fuel reduction without dramatically altering the cultural landscape that is Chautauqua.

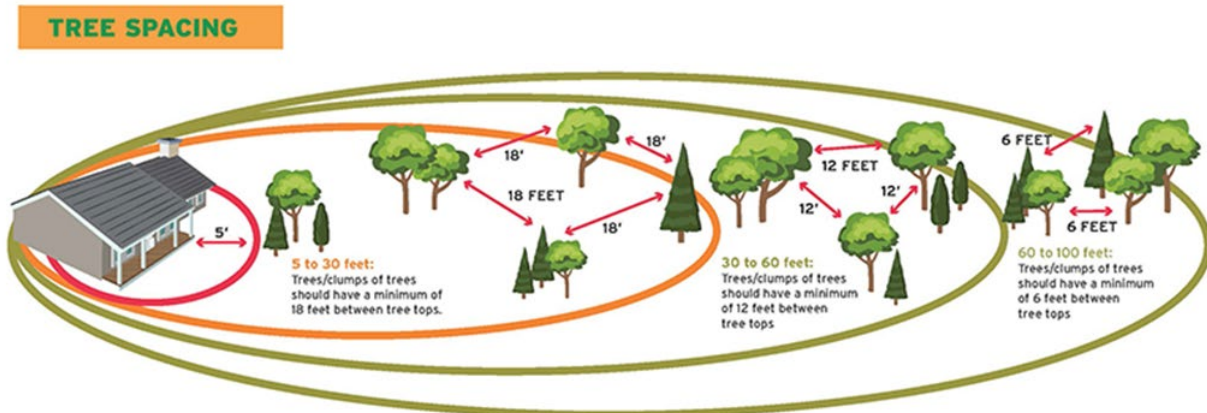
Figure 6. Defensible space as recommended by removing or trimming vegetation to eliminate horizontal and vertical fuel continuity to reduce the risk of the fire spreading and making fire operations more challenging and less safe.

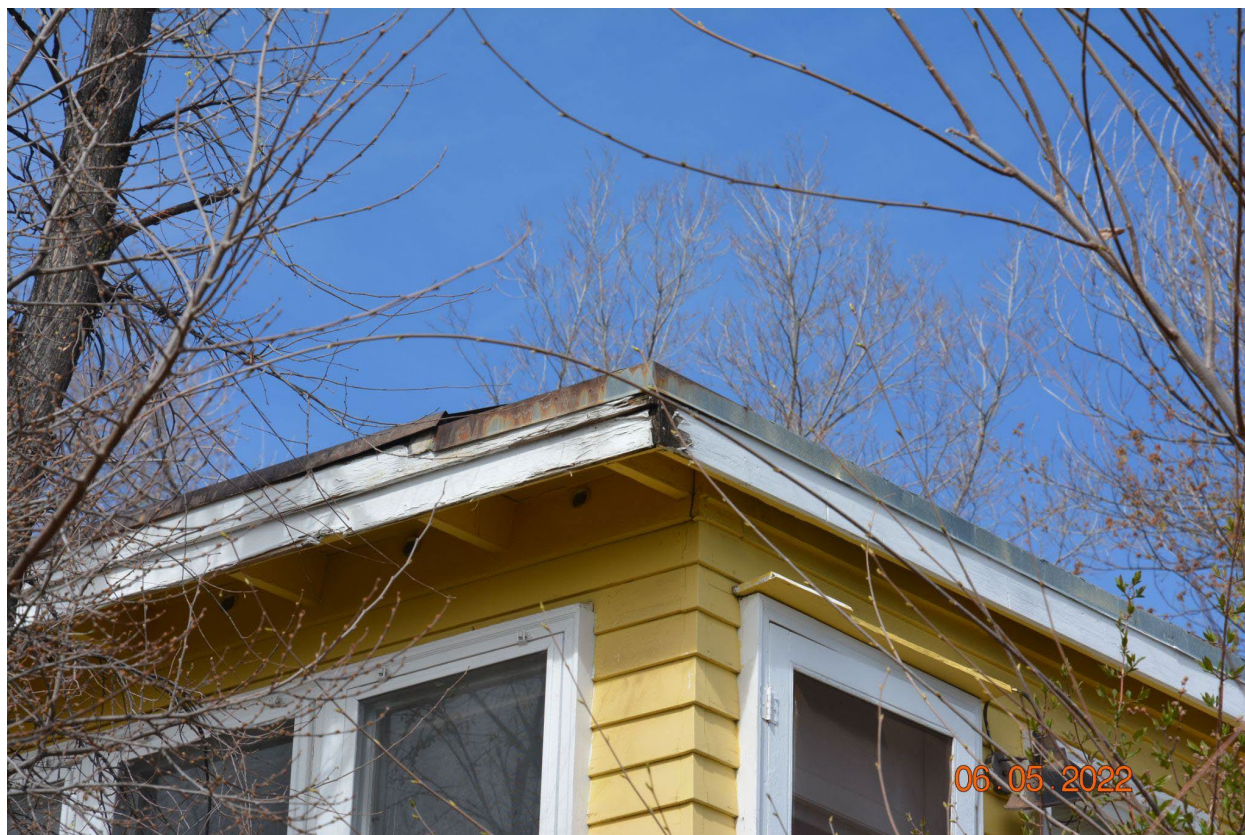
Figure 7. Deteriorated fascia board that provides an entry for wind-blown embers can result in an ignition on the interior of the structure.

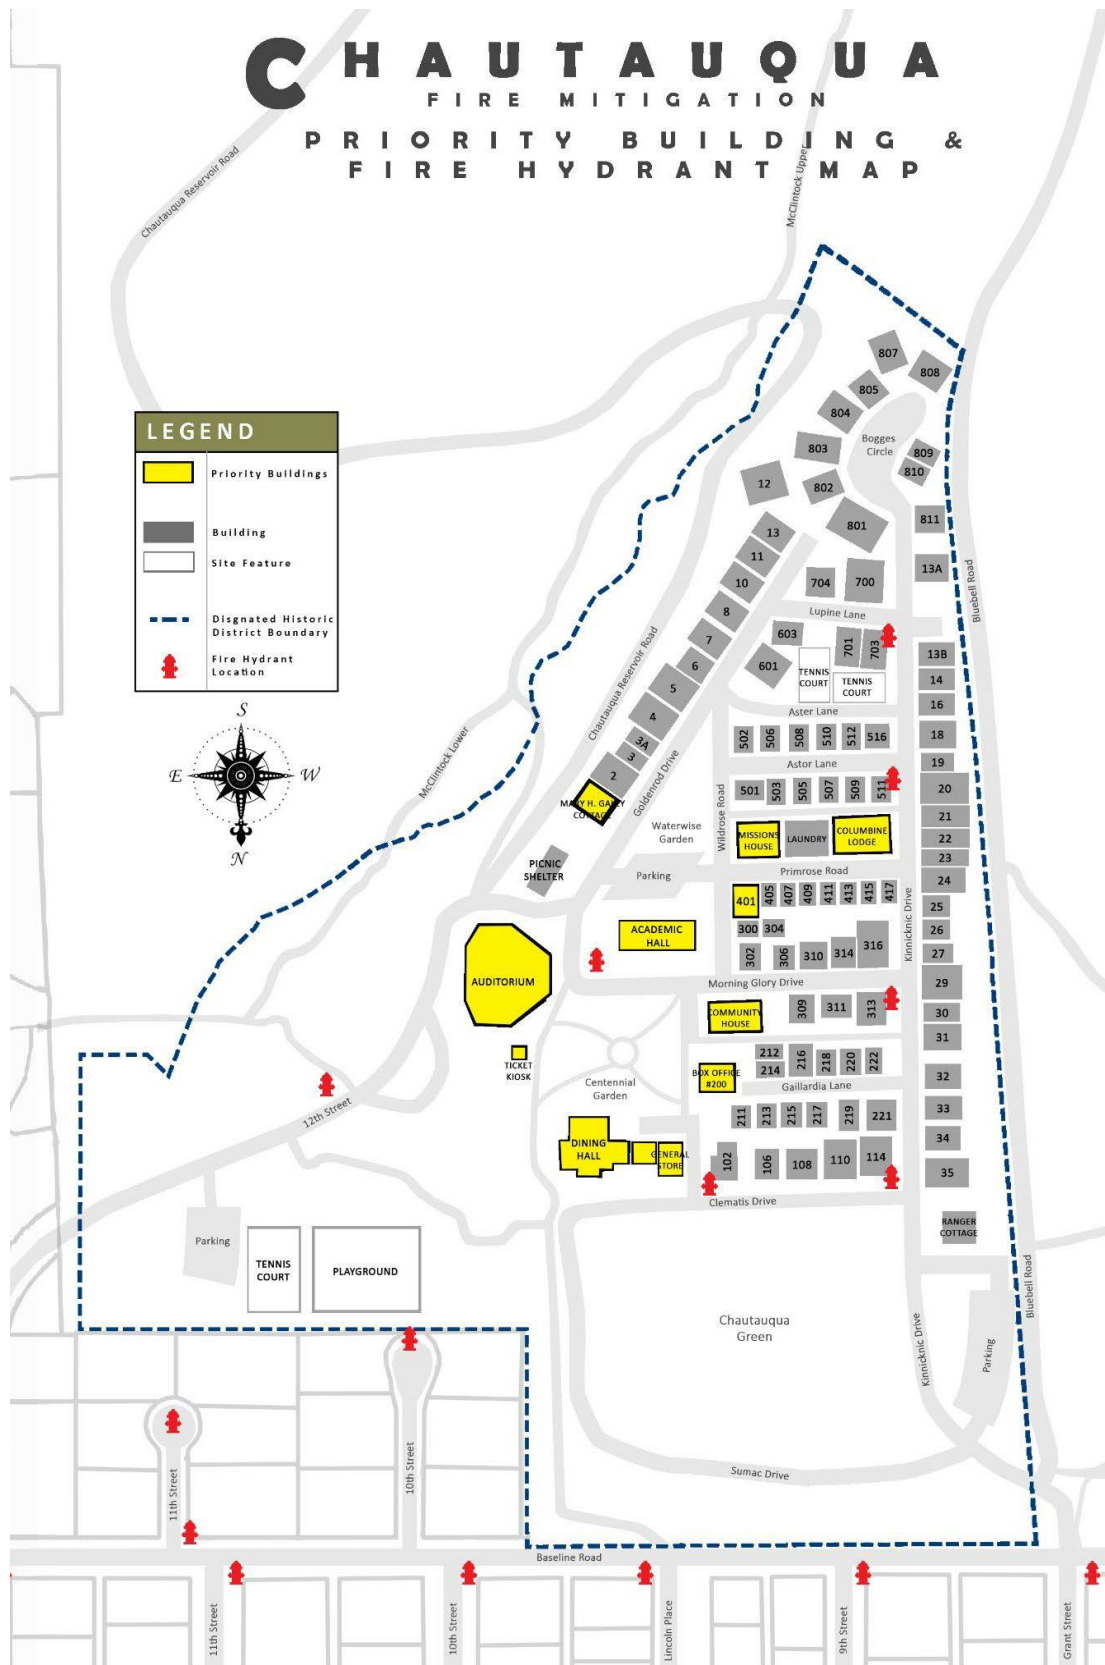
Figure 10. Chautauqua Priority Buildings and Fire Hydrants Map

As part of this project, the Team worked with CCA to determine a list of priority buildings. The thinking behind this effort was, in the event of an oncoming fire, if firefighters are able to only save a single structure, what would that be? With this starting point the Team then listed the next highest priority structures for firefighters should the opportunity allow for additional structures to be saved. The following is the list of prioritization and location maps, the intent is that this section of the document could be removed as a standalone document to be distributed to local and visiting emergency services:

Name	Address
1	Auditorium	198 Goldenrod Drive, Boulder, CO 80302
2	Dining Hall / General Store	100 Clematis Drive, Boulder, CO 80302
3	Community House	301 Morning Glory Drive, Boulder, CO 80302
4	Academic Hall	298 Morning Glory Drive, Boulder, CO 80302
5	Missions House	400 Primrose Road, Boulder, CO 80302
6	Columbine Lodge	410 Primrose Road, Boulder, CO 80302
7	Cottage 200 (Box Office)	212 Chautauqua Trail, Boulder, CO 80302
8	Mary H. Galey Cottage	1 Chautauqua Trail, Boulder, CO 80302
9	The Rest Cottage (#401)	401 Chautauqua Trail, Boulder, CO 80302

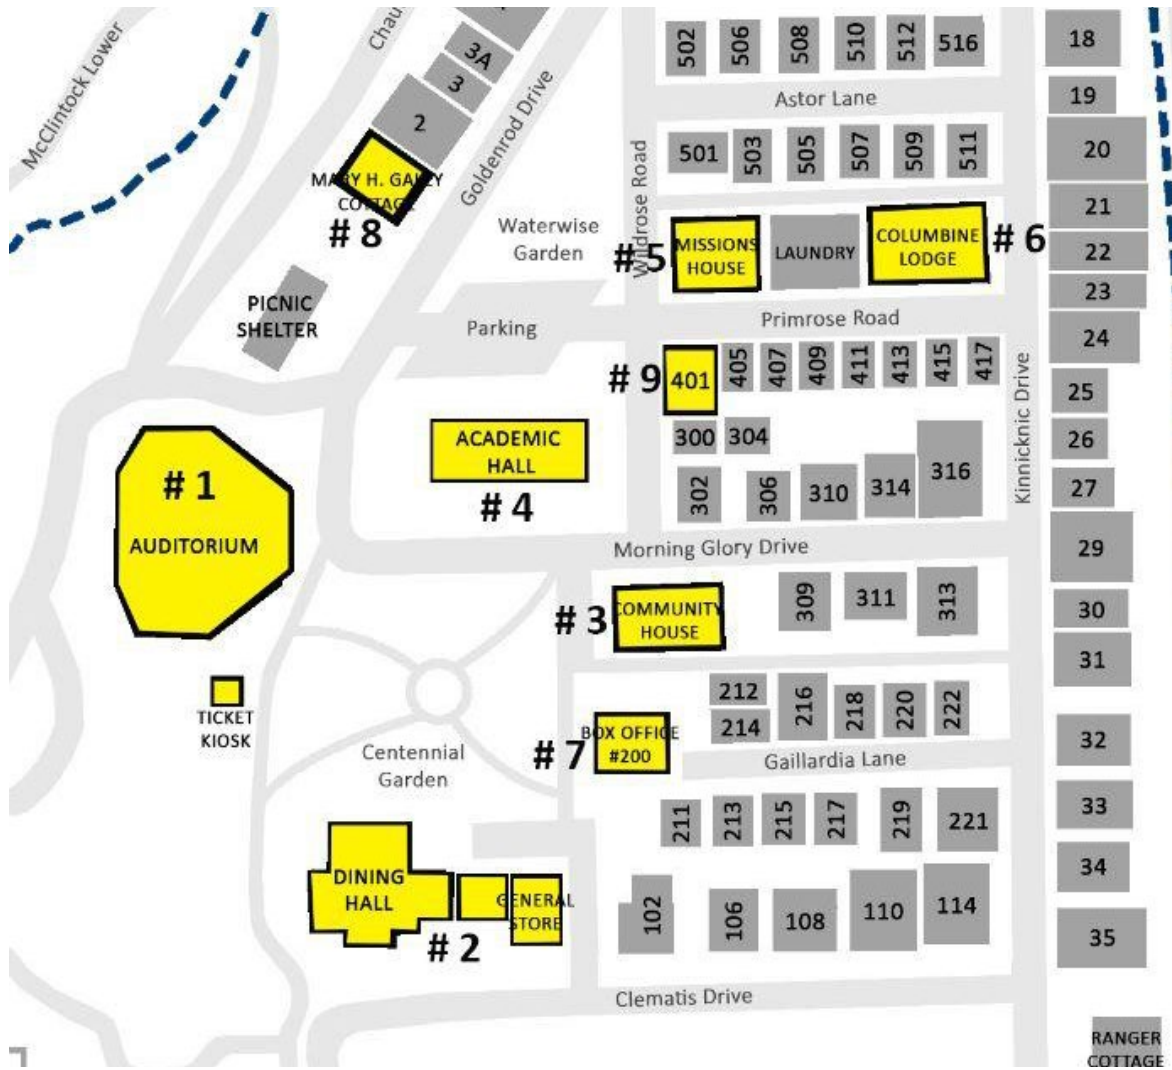
Figure 11. Order of Priority Buildings

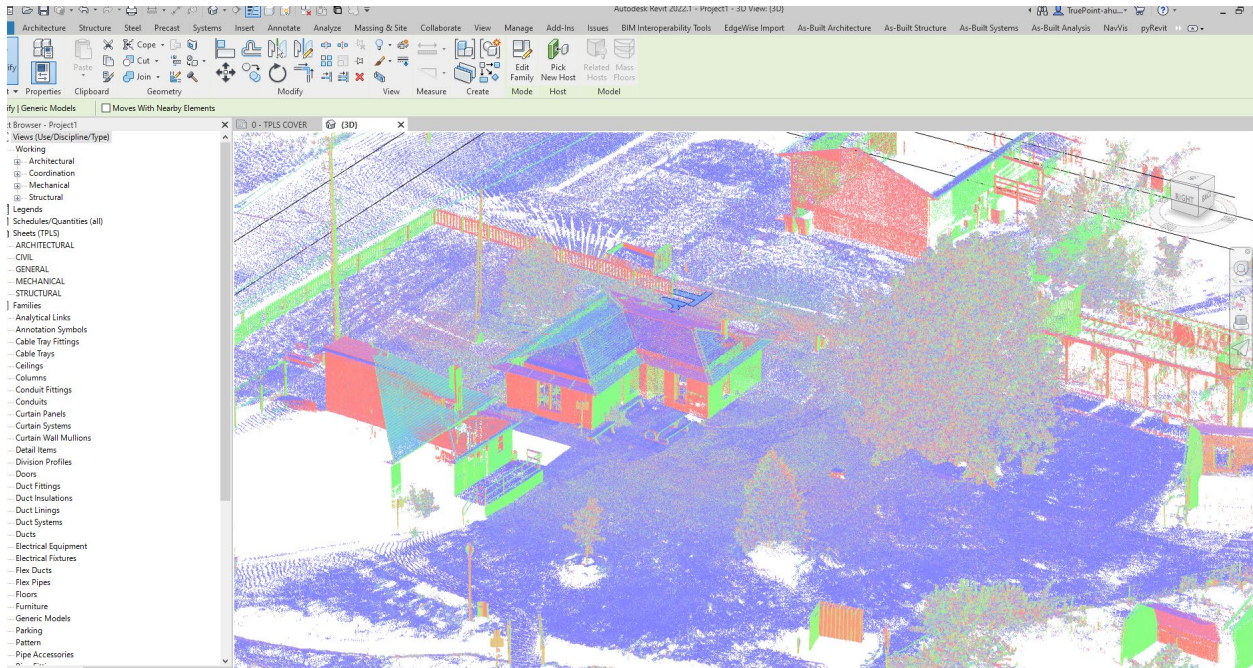
Figure 12. A point cloud file from a LiDAR scan imported into Revit (an Autodesk program utilized to create architectural and engineering 3D models and drawings of buildings).

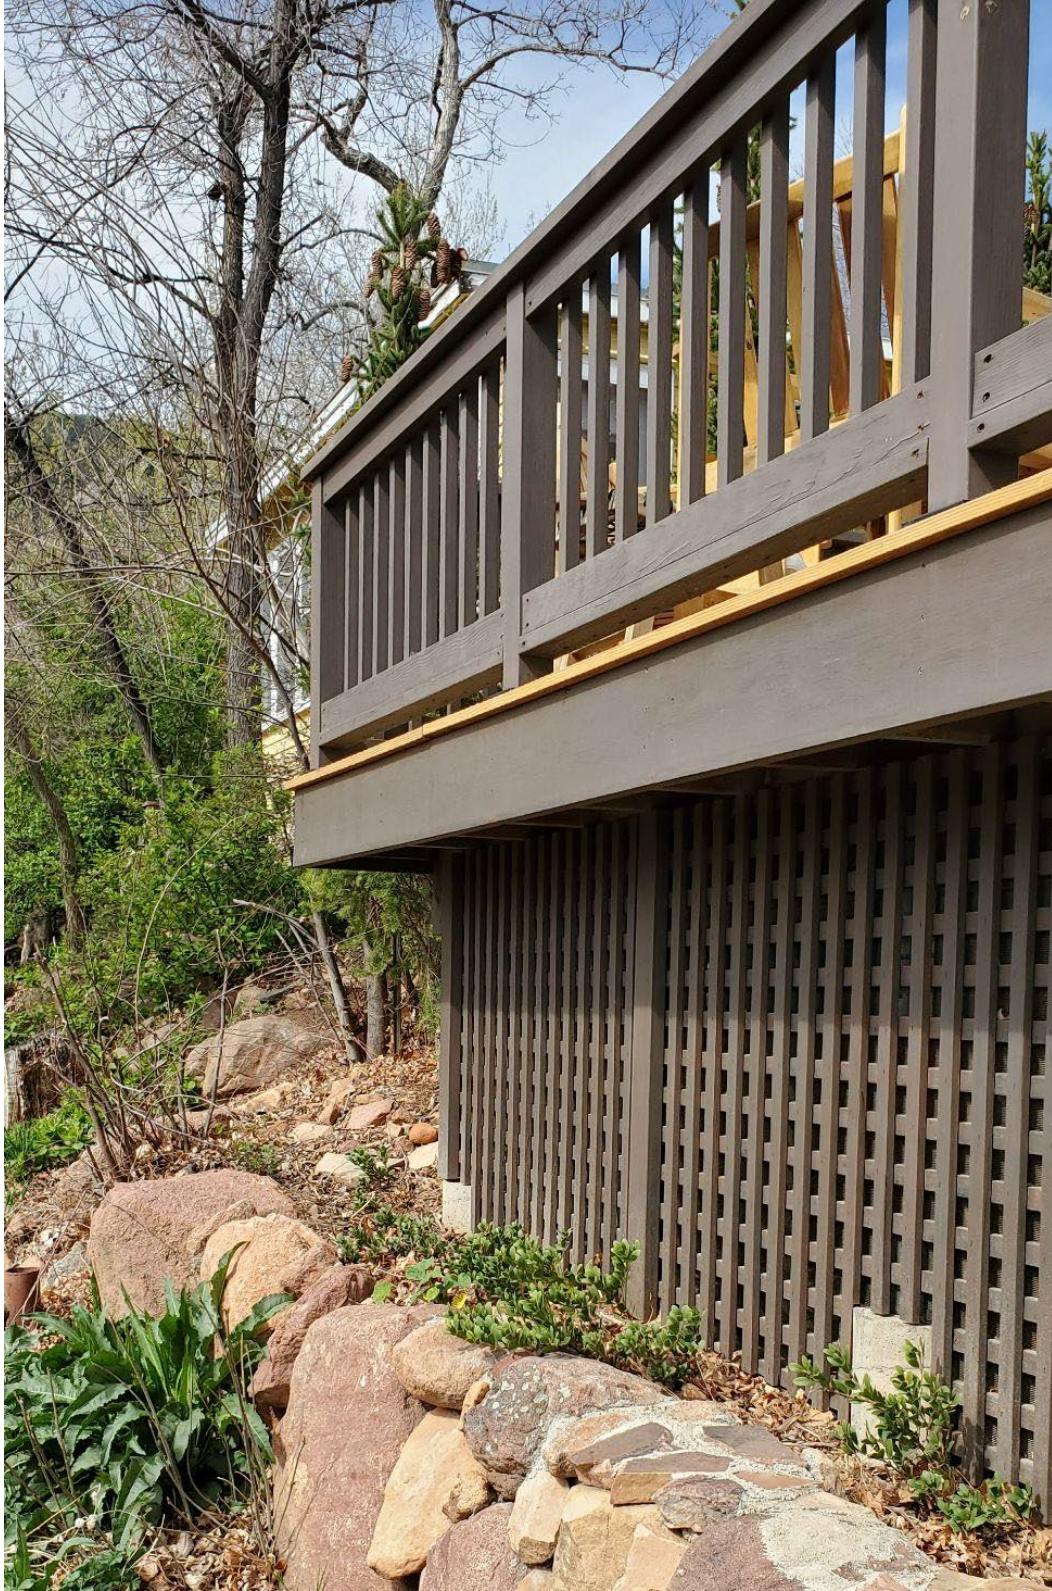
Figure 13. Mary H. Galey Cottage deck enclosure. The enclosure uses fire-retardant-treated wood and metal mesh to reduce combustibility and the likelihood of large embers causing ignition under the deck.
